PROCUREMENT FOR: Asbestos Abatement at the Old Gallman School

**Hazardous Materials Assessment Report
Gallman School
540 Brantley Street
Newberry, South Carolina
S&ME Project No. 22610550R.1**

Reference: **Hazardous Materials Assessment Report**
Gallman School
540 Brantley Street
Newberry, South Carolina
S&ME Project No. 22610550R.1

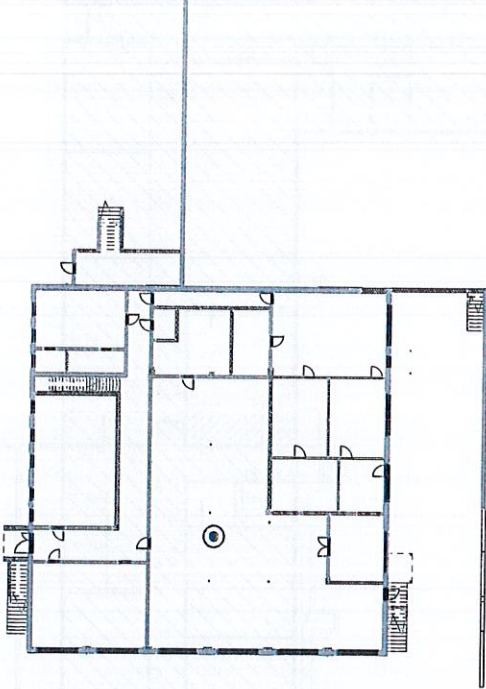
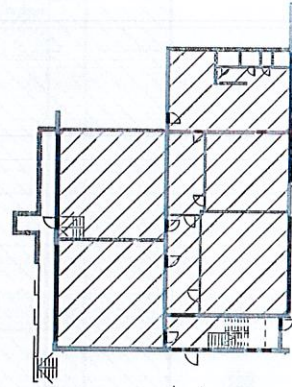
FIGURE NO.:
1

ASBESTOS CONTAINING MATERIALS

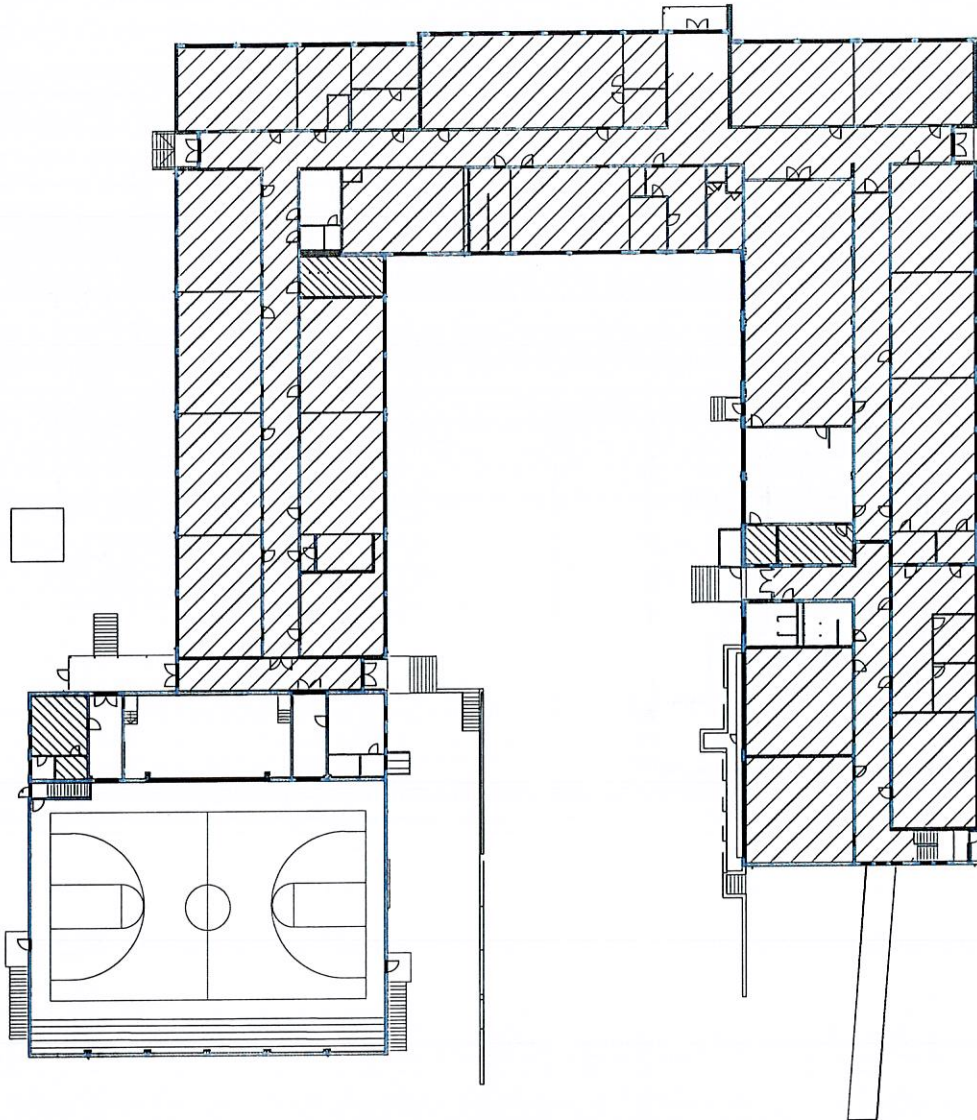
**HAZARDOUS MATERIAL ASSESSMENT
SECOND LEVEL**

- 12" DARK TAN VCT AND BLACK WITH 9" BROWN VCT AND MASTIC BENEATH
- 9" BROWN VCT AND MASTIC

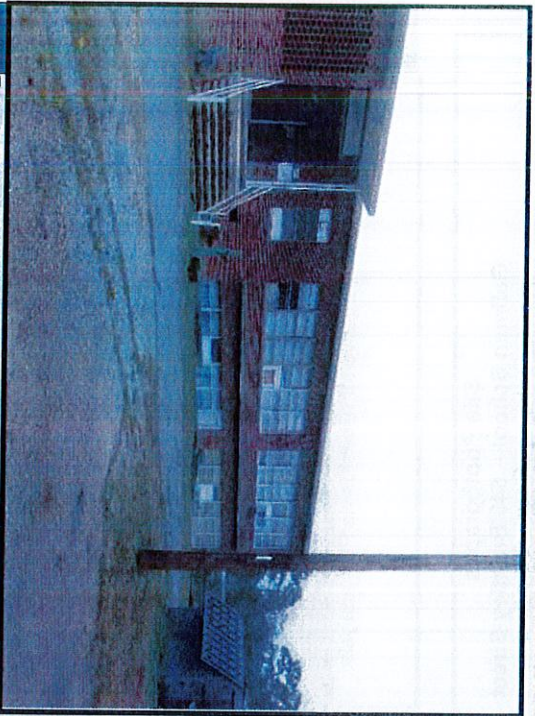
1 Exterior view of the subject building.

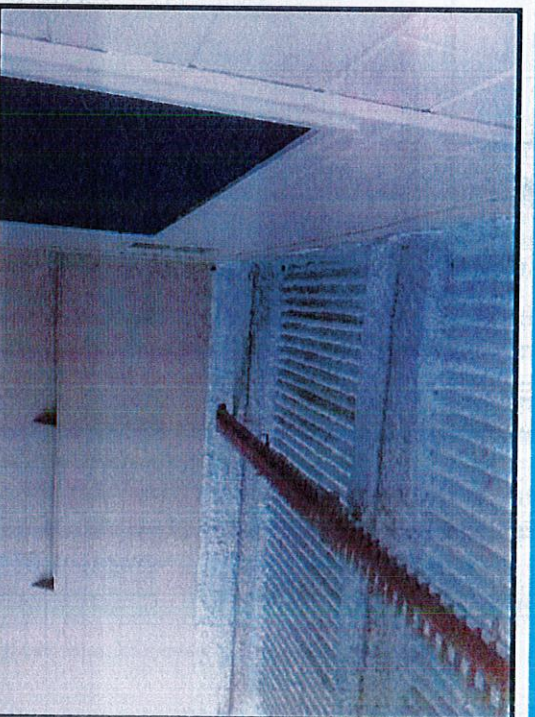
2 Spray-applied fire proofing tested negative for asbestos via PLM analysis.

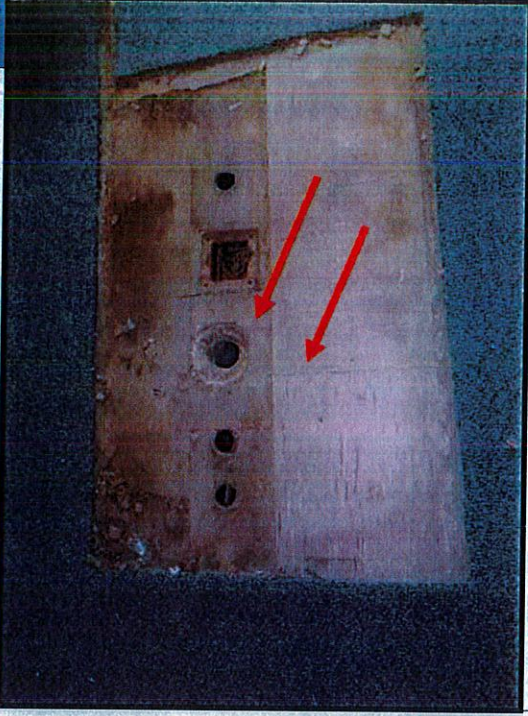
3 12-inch dark tan vinyl floor tile and black mastic and 9-inch brown vinyl floor tile and mastic tested positive for asbestos (3%-6% chrysotile).

S&ME recommends proper removal and disposal of the ACMs by a licensed asbestos abatement contractor, prior to activities that may disturb an ACM. State and Federal regulations should be carefully considered in order to verify compliance before any actions are initiated that may disturb an ACM. If additional suspect ACMs not included in this report are discovered and will be disturbed by the renovation/demolition activities, bulk samples must be collected by a licensed asbestos inspector and analyzed for asbestos content, prior to disturbance of the suspect material(s).

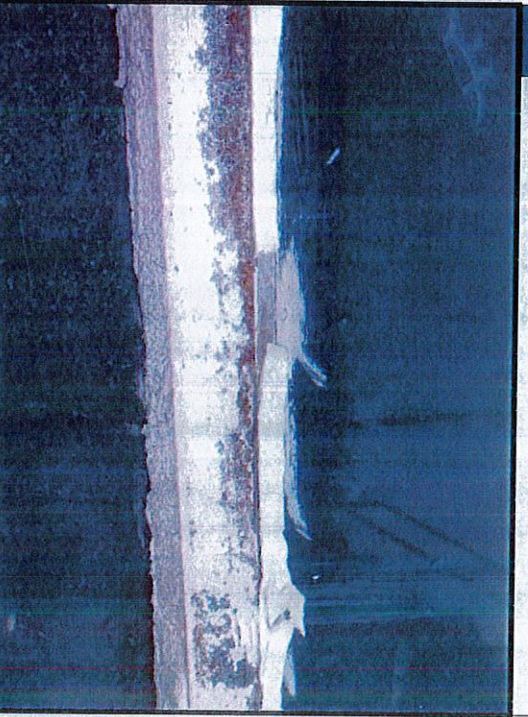
4 Window glazing tested positive for asbestos (2% chrysotile).

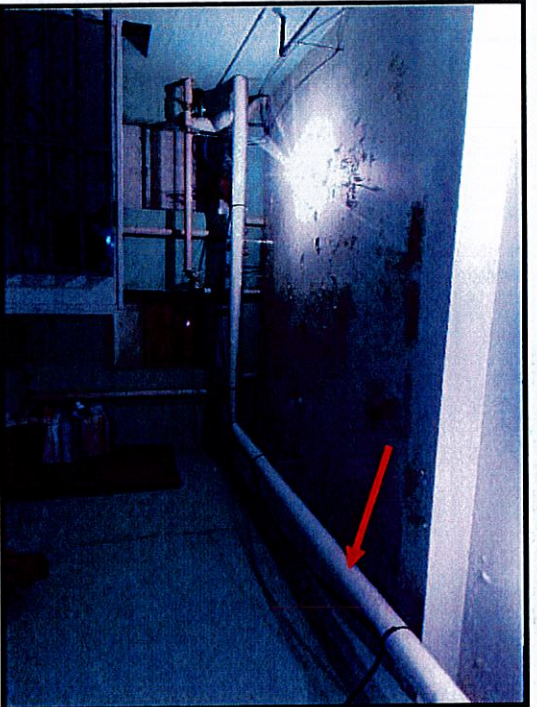
5
TSI tested positive for asbestos (15% amosite and 3% chrysotile).

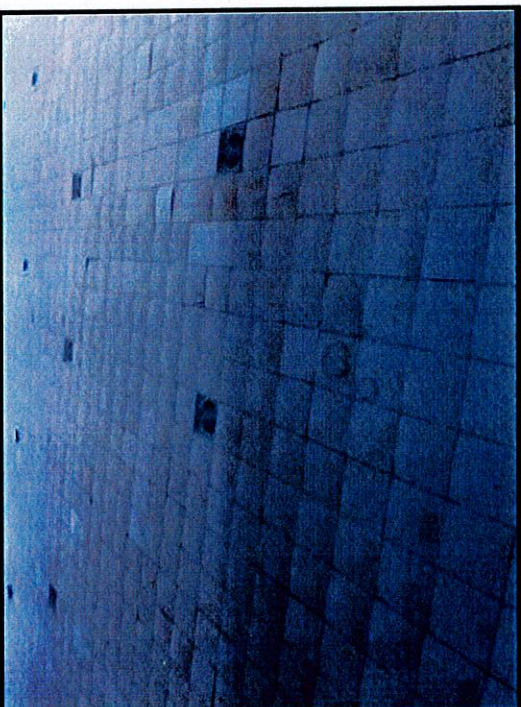
7
2x2 ceiling tile tested negative for asbestos via PLM analysis.

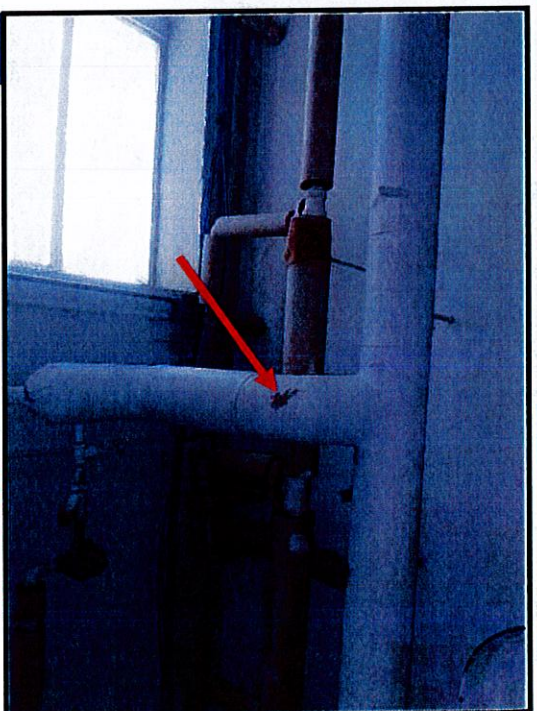
6
Hard joint tested positive for asbestos (65% chrysotile).

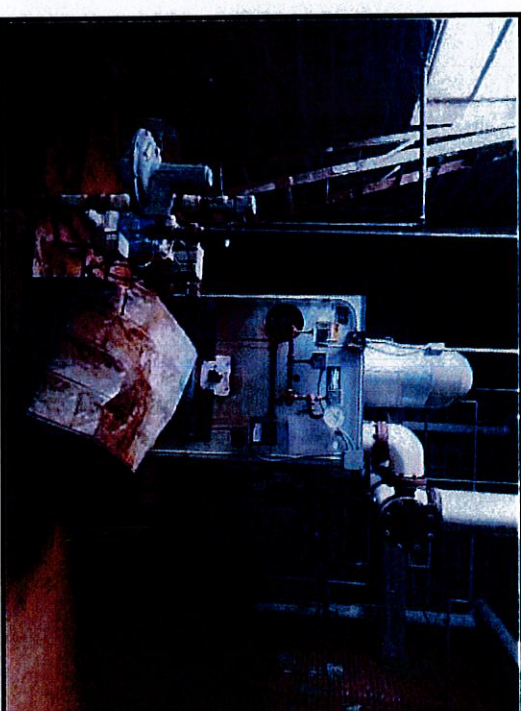
8
General view of boiler room.

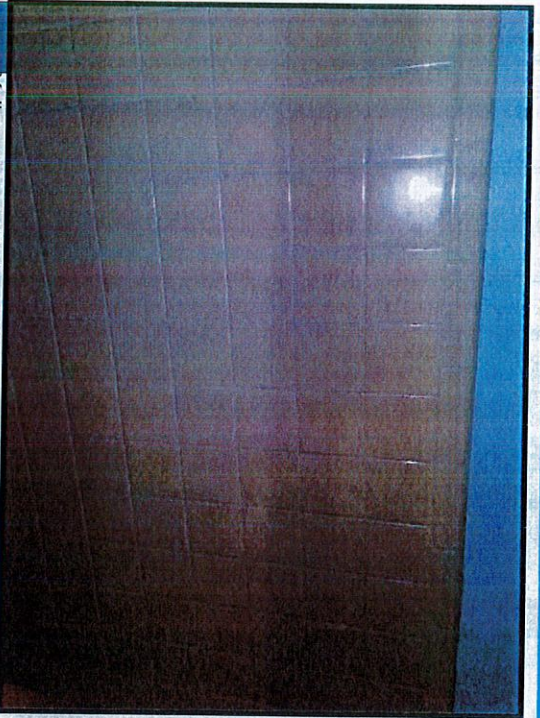
9 Yellow ceramic tile in men's restroom tested positive for lead-based paint (7.70 mg/cm²).

The client is advised that OSHA does not recognize a threshold level of lead for definition purposes, only the presence or absence of lead. Consequently, the OSHA regulations governing worker protection for lead-based paint may apply to work practices including the disturbance of paint systems with detectable levels of lead. Destructive actions (sanding, burning, demolition, component removal, paint preparation) to the lead-containing paint surfaces will require the contractor comply with the standards of OSHA, including but not limited to initial exposure monitoring, the use of personal protective equipment, and medical surveillance.

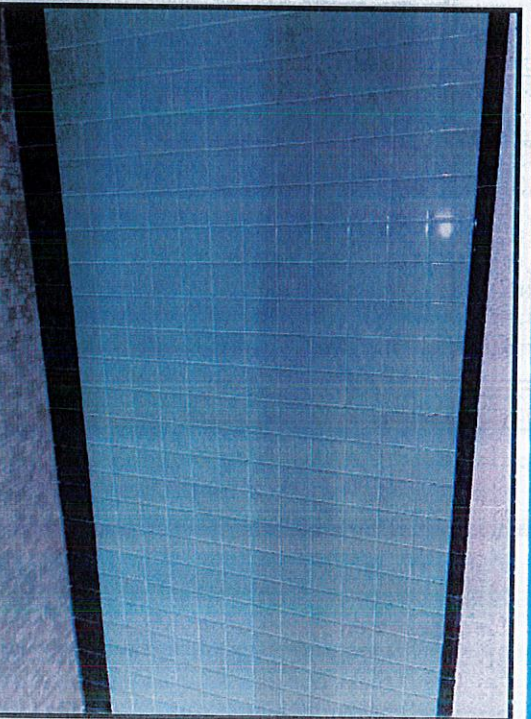
10 Green and black ceramic tile in men's restroom tested positive for lead based paint (5.40-19.90 mg/cm²).

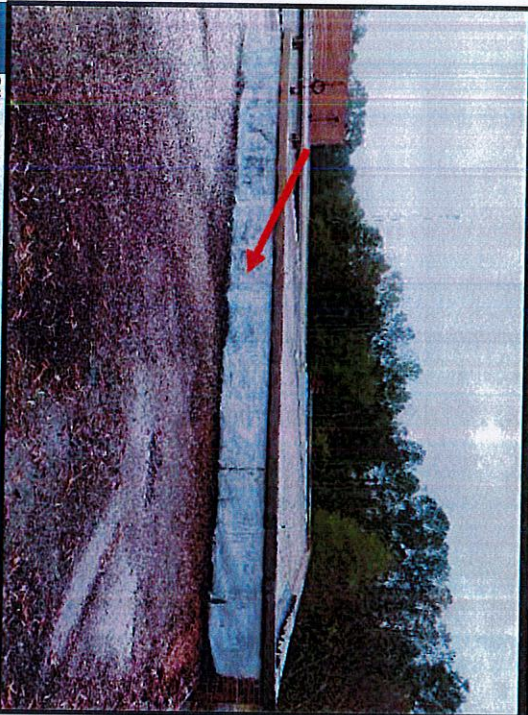
11 Silver sealant on parapet walls tested (<1% chrysotile) PLM analysis and no asbestos detected by TEM.

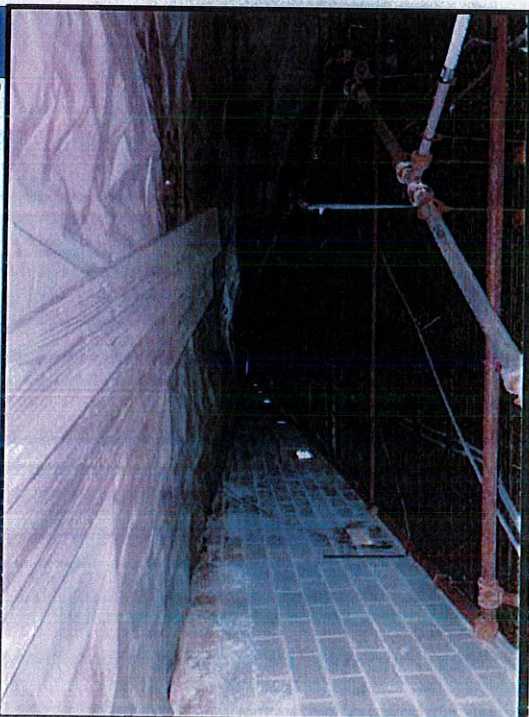
12 General view of crawlspace.

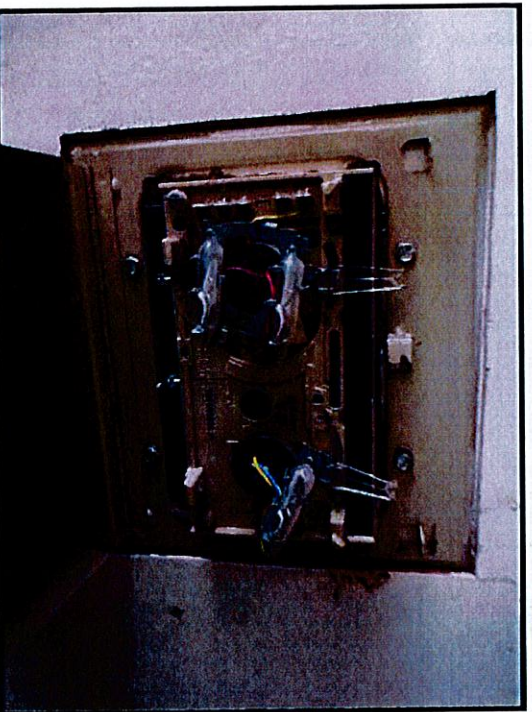
Two thermostats were observed in the cafeteria. No additional sources of mercury were noted during the assessment.

13 Mercury thermostat in the cafeteria.

The fluorescent light tubes observed in the building's light fixtures inherently contain low levels of mercury and must be recycled or properly disposed as mercury sources. Mercury is designated as a Universal Waste by the EPA under 40 CFR 273, the Resource Conservation and Recovery Act (RCRA). The state of South Carolina has no formal mercury program and has adopted the EPA regulations for proper handling and disposal of mercury-containing sources. Should these materials be disturbed as a part of future renovation or demolition, S&ME recommends removal of the mercury-containing lamps prior to the planned activities, and recycling at a Universal Waste Destination Facility.

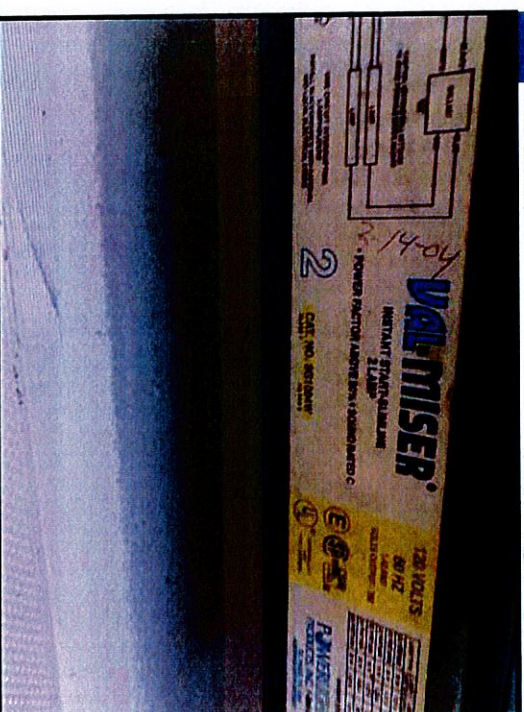
15 Ballast presumed to contain PCBs.

PCBs are regulated by the EPA found in 40 CFR 761, the Toxic Substance Control Act (TSCA). PCB-containing equipment cannot be disposed of in Solid Waste Landfills (SWLF) in the State of South Carolina according to R61-107.16. The EPA and SCDHEC require proper disposal of equipment containing PCBs per 40 CFR 761 subpart D of TSCA.

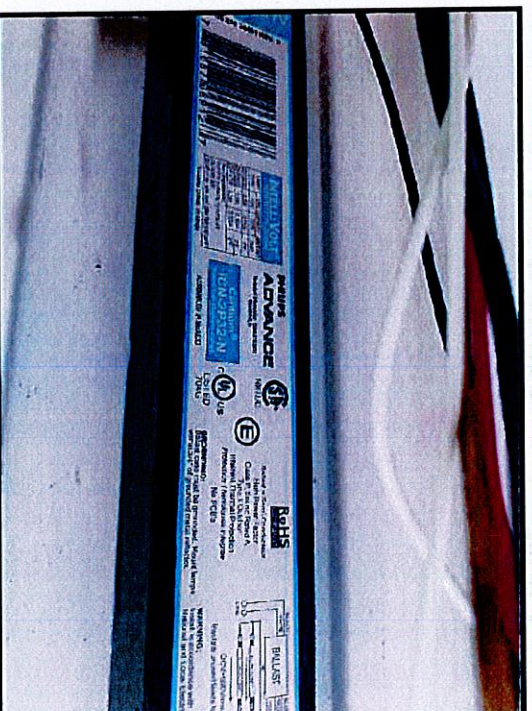
14 Ballast labeled no PCBs.

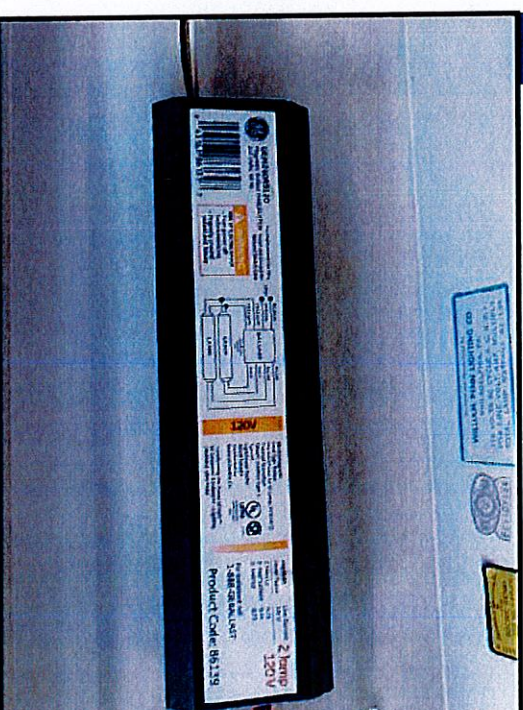
16 Electromagnetic ballast no PCBs.
