**ADDENDUM ONE
Invitation for Bids No.: 2025-18
Newberry County Museum Roof Renovations**

Roof Assessment & Report

Newberry Museum

Issued: April 25, 2025

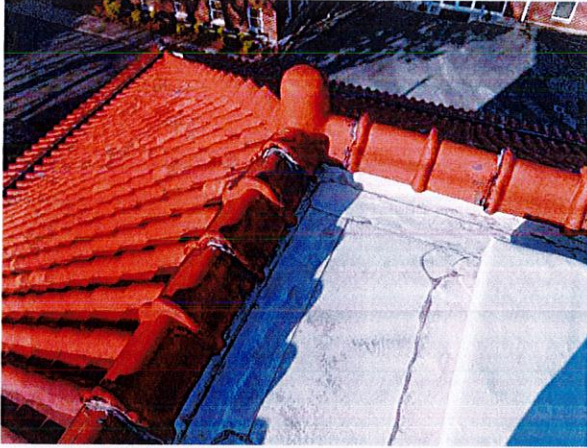
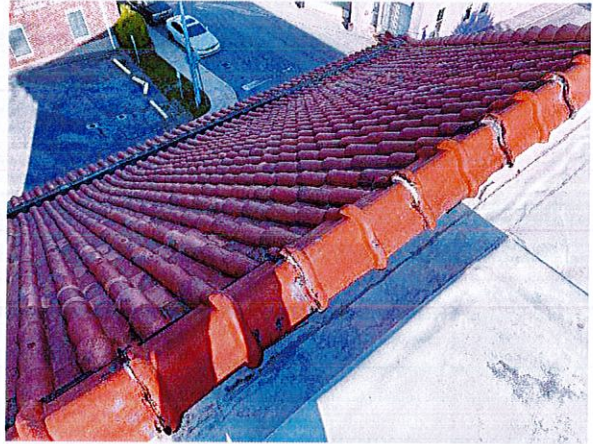
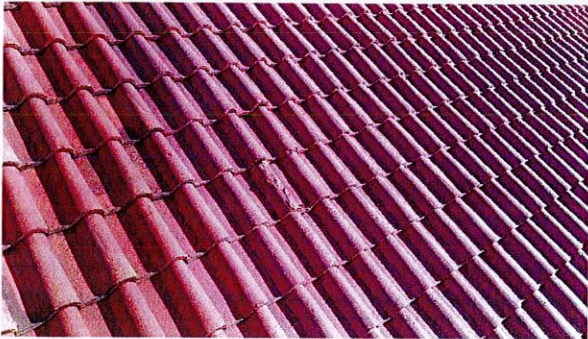
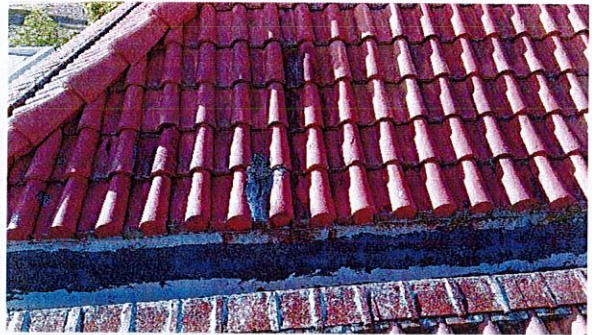
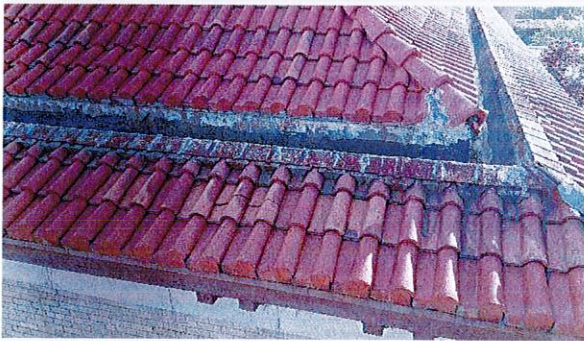
- a. Repairs have been performed using sealants, mastics and coatings in several areas indicating past problem areas.
- b. Copper step flashing does not cover the adjacent flashing piece and has left an opening for moisture intrusion to occur.

Repairs using sealants, mastics and coatings

Repairs rmed using sealants, mastics and coatings

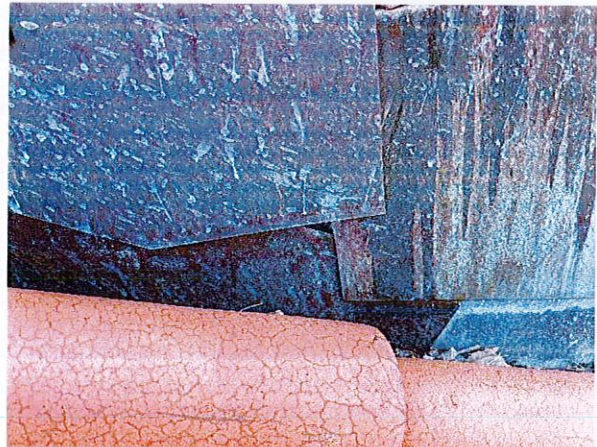
Copper step flashing does not cover the adjacent flashing piece

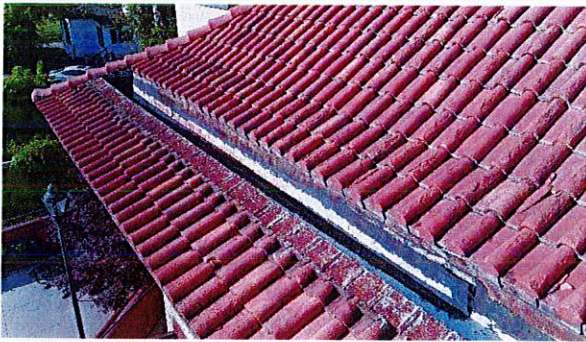
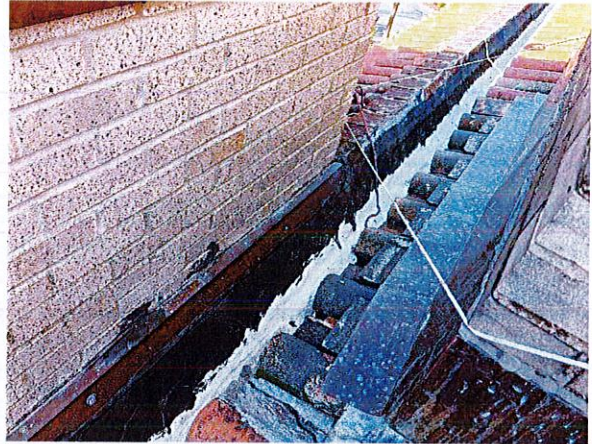
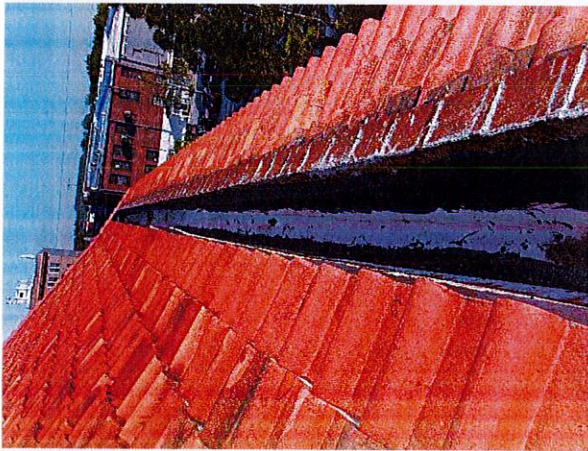
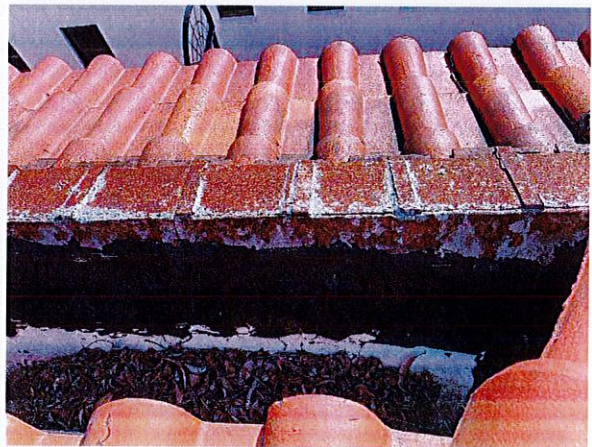
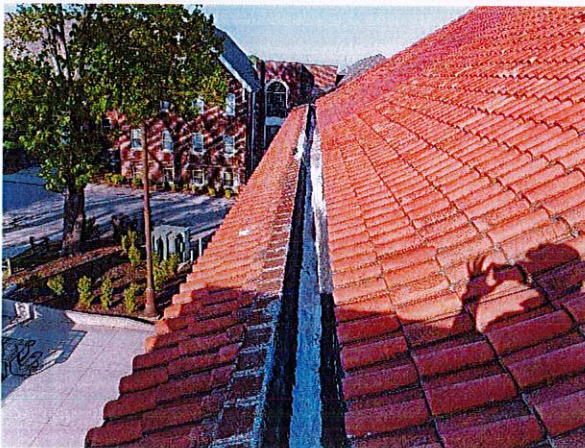
- c. Substantial deterioration of the built-in gutter system is evident. Several repairs have been attempted using mastics, coatings, sealants and thermoplastic membrane indicating that this is a past problem area.

- d. The built-in gutter system does not have provisions for expansion and contraction which puts undue stress on the gutter system. Provision for expansion and contraction needs to be provided, which will require the addition of new drainage points. New drainage points could be easily provided if an external gutter and downspout system are installed.

Substantial deterioration of the built-in gutter system

- A. Replacement of the clay barrel roof tile system at the subject facility is recommended when funds become available. We would also recommend that the built-in gutter system be bypassed, and an external gutter and downspout system be installed if allowed by the historical review committee. This would allow for the addition of new drainage points for the roof system.
- B. We also recommend that random repairs be performed on the other roof areas when this work takes place. Although we do recommend that the thermoplastic roof areas be repaired as a minimum, this area should also be considered for replacement when the replacement of the tile roofing is performed due to the overall size being minimal and the difficulty in getting to it.

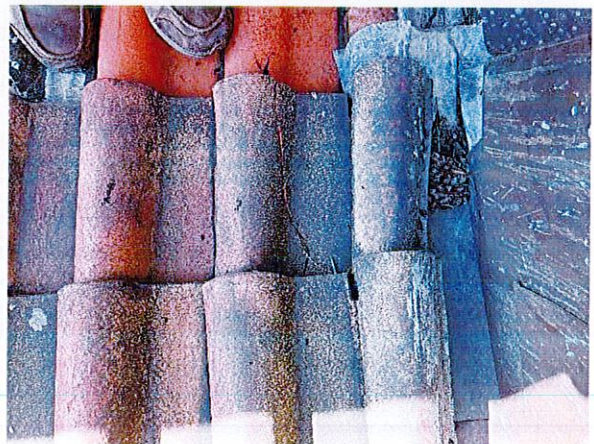
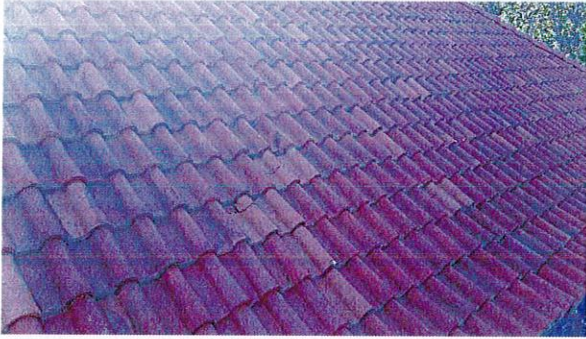
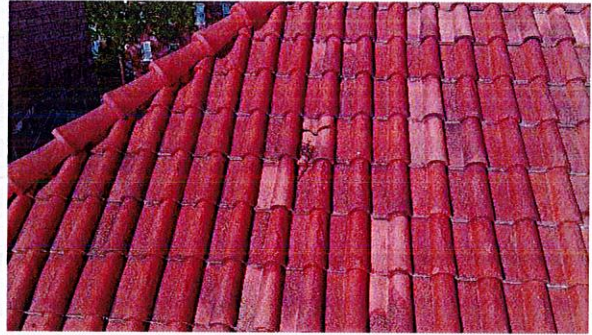
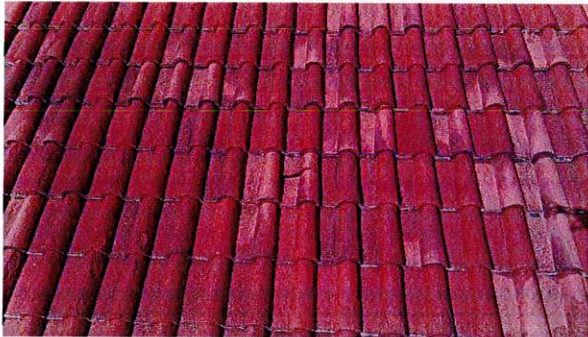
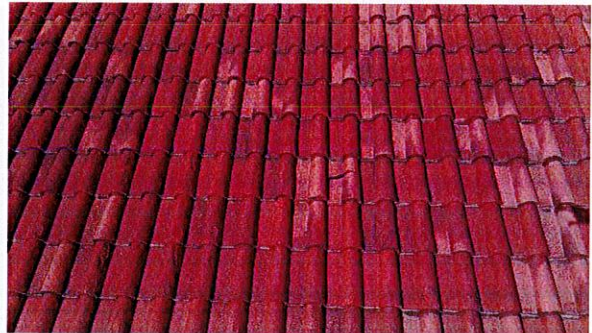
- e. Random areas of missing, broken and dislodged tiles were noted. A couple of areas were noted where different hip tiles were used.
- f. Some random areas of substantial freeze/thaw damage to the clay tiles were evident.

Broken and dislodged tiles

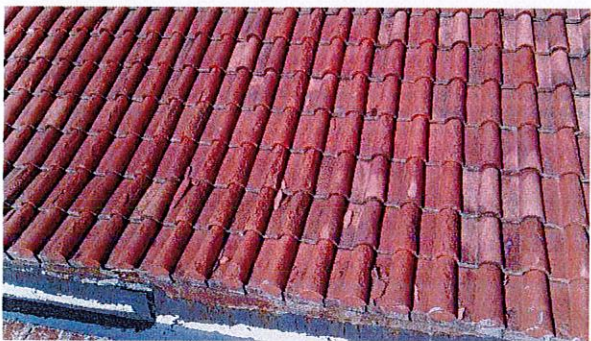
Substantial freeze/thaw damage to the clay tiles

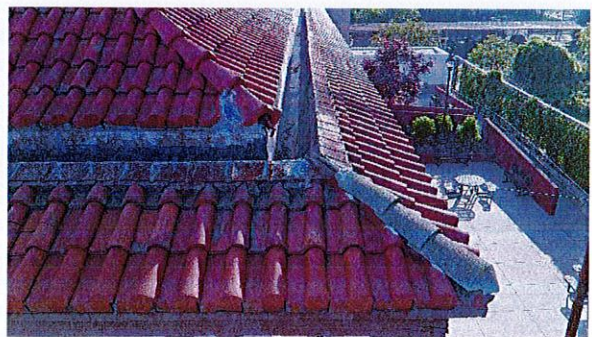
- g. One area was noted where the hip tiles were missing where they are supposed to span over the built-in gutter system.

Hip tiles were missing where they are supposed to span over the built-in gutter system

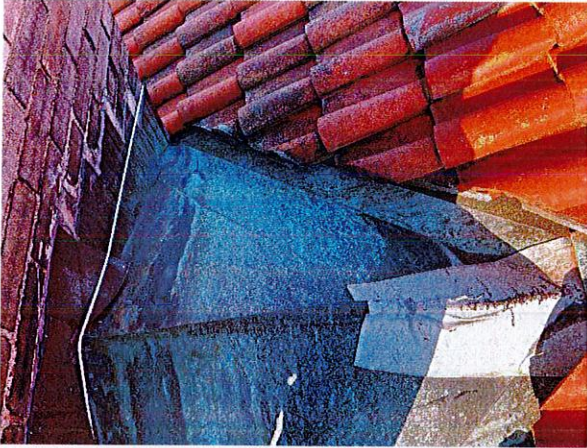
- h. There are several areas where dissimilar materials come into contact with each other that can cause premature deterioration/failure.
- i. Deterioration of sealants was noted in a couple of locations.
- j. Debris was noted in the built-in gutter system obstructing proper drainage.

Dissimilar materials (lead and copper)

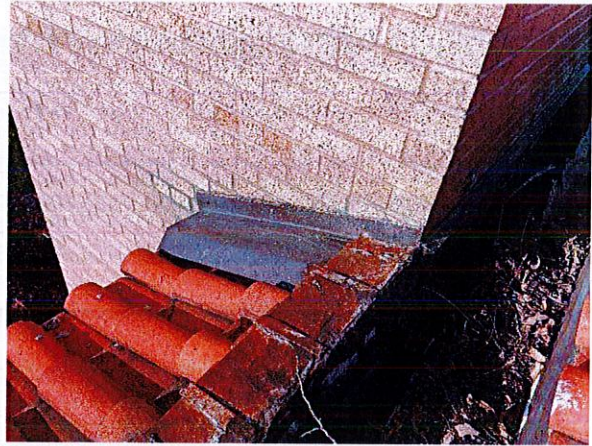
Dissimilar materials (steel and copper)

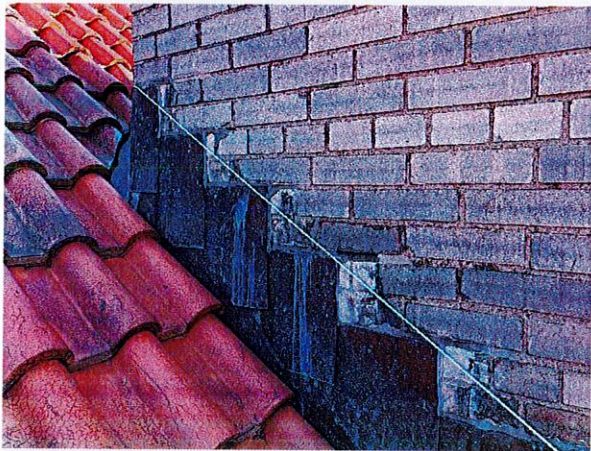
Deterioration of sealants

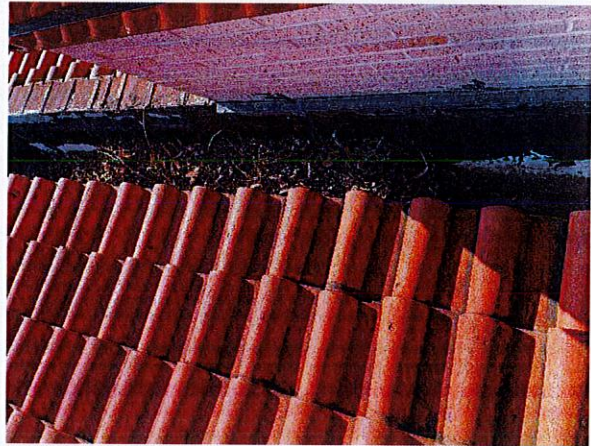
Debris in the built-in gutter system

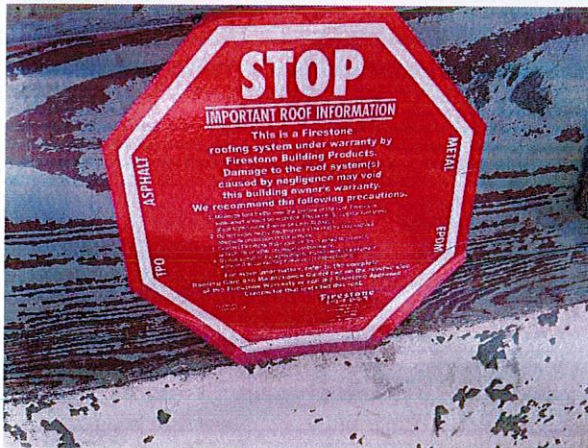
Membrane likely manufactured by Firestone Building Products

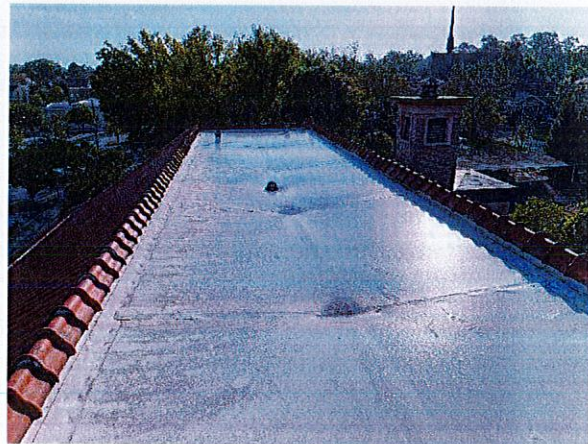
Minor ponding water was evident

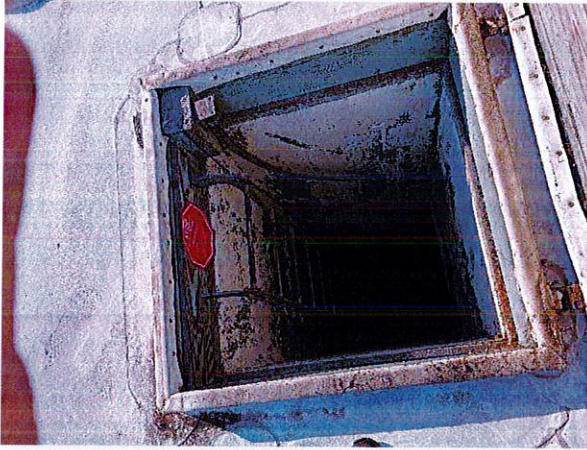
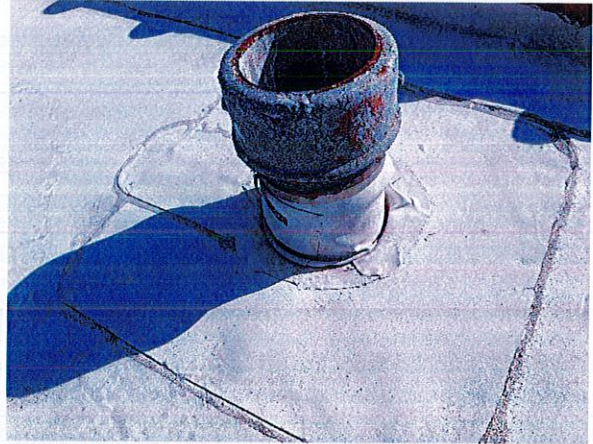
Penetration flashings have some deterioration evident

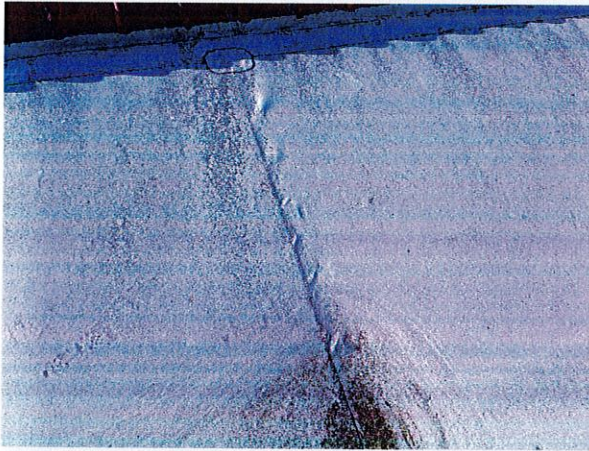
Wrinkles run through a lap of the roof membrane

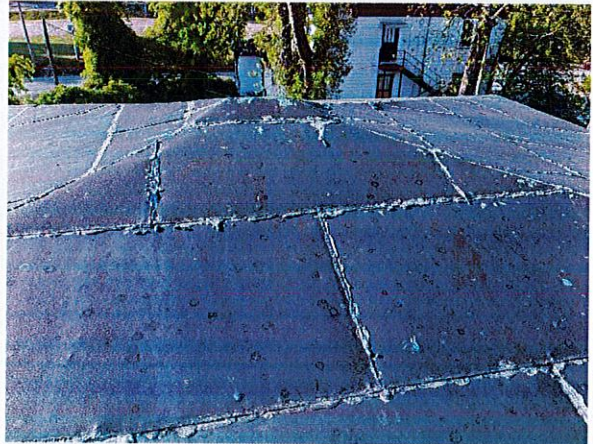
- a. The soldering of the flat seam copper roofing system seams is not smooth in most locations. Smooth soldered seams are an indication of a fully soldered joint. However, it's possible that the joints have been soldered fully even though they do not appear smooth, and no leaks were reported in this area.
- b. Deterioration of the paint/coating system on the flat seam terne roofing system was evident.
- c. Debris was noted in the built-in gutter system of the flat seam terne roofing system obstructing proper drainage.
- d. Some random sealant deterioration was noted on the flat seam terne roofing system.

Soldering of the flat seam copper roofing system seams is not smooth

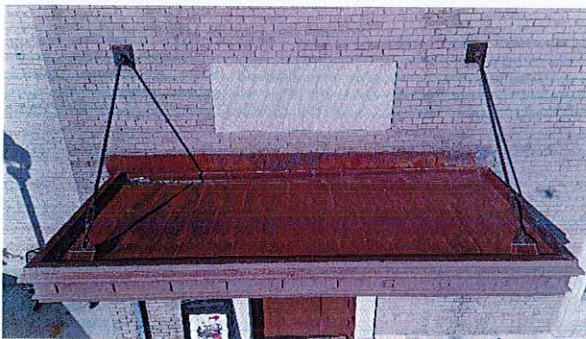
Deterioration of the paint/coating system on the flat seam terne roofing

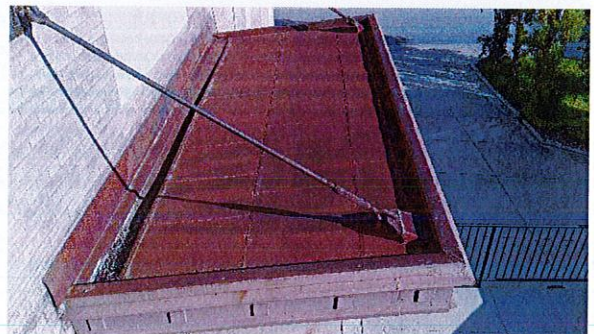
Deterioration of the paint/coating system on the flat seam terne roofing. Debris was also noted in the built-in gutter system
