SECTION 00 90 10 ADDENDUM NO. 1

Project: Gallman Place Roof Renovation
Newberry, SC 29108
23234 – A

Hazardous Materials Assessment Report
Gallman School
540 Brantley Street
Newberry, South Carolina
S&ME Project No. 22610550R.1

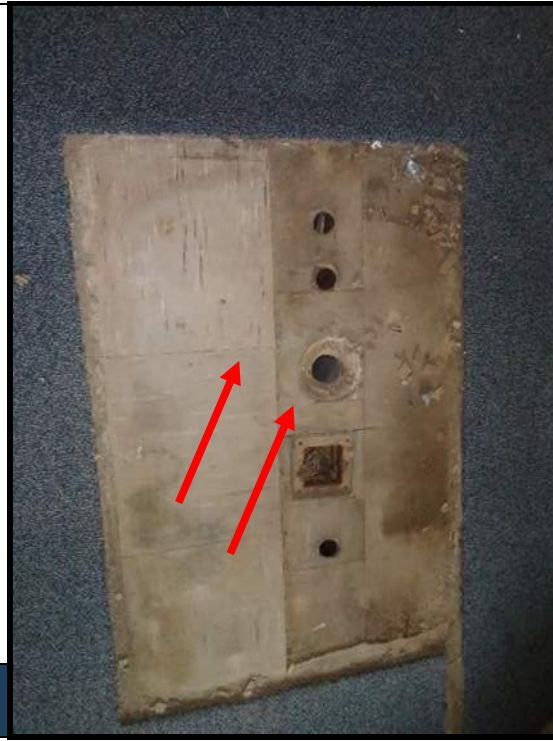
3 12-inch dark tan vinyl floor tile and black mastic and 9-inch brown vinyl floor tile and mastic tested positive for asbestos (3% chrysotile).

S&ME recommends proper removal and disposal of the ACMs by a licensed asbestos abatement contractor, prior to activities that may disturb an ACM. State and Federal regulations should be carefully considered in order to verify compliance before any actions are initiated that may disturb an ACM. If additional suspect ACMs not included in this report are discovered and will be disturbed by the renovation/demolition activities, bulk samples must be collected by a licensed asbestos inspector and analyzed for asbestos content, prior to disturbance of the suspect material(s).

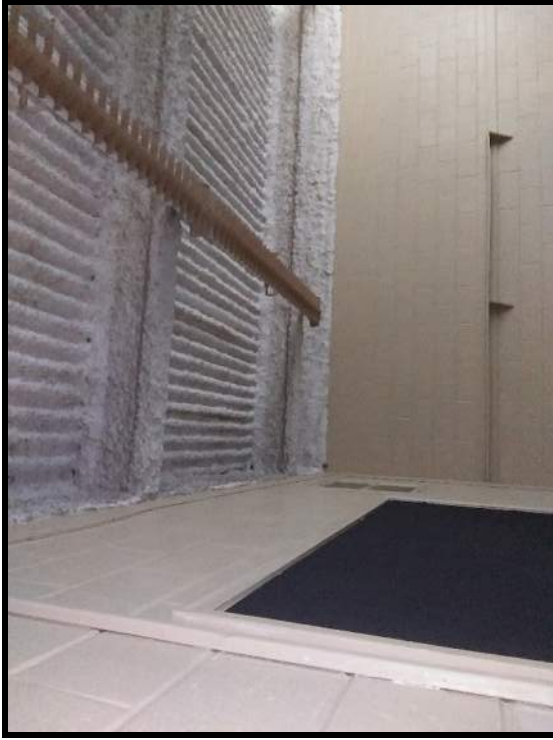
2 Spray-applied fire proofing tested negative for asbestos via PLM analysis.

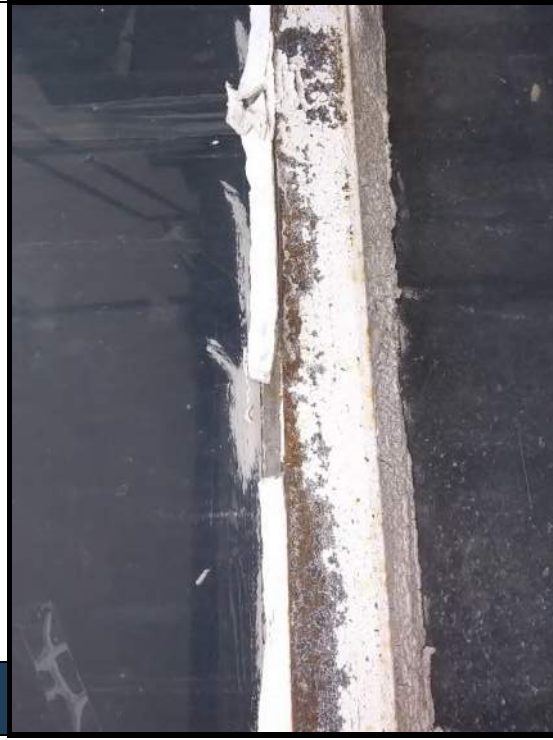
4 Window glazing tested positive for asbestos (2% chrysotile).

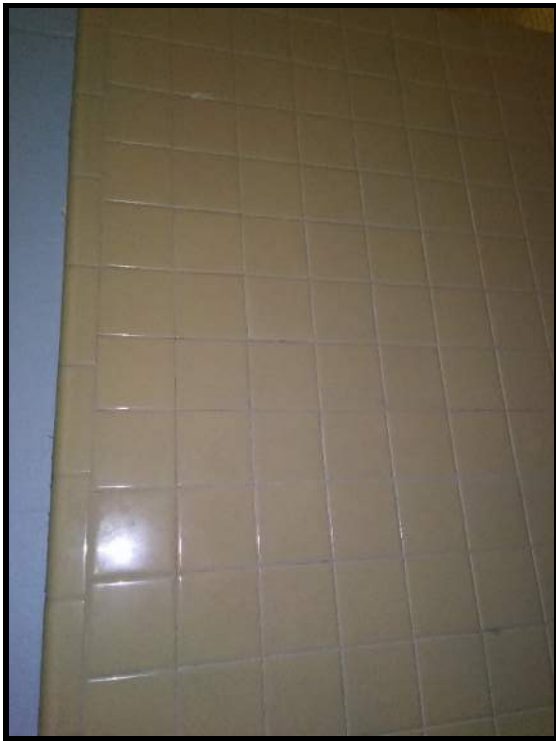
9 Yellow ceramic tile in men's restroom tested positive for lead-based paint (7.70 mg/cm²).

The client is advised that OSHA does not recognize a threshold level of lead for definition purposes, only the presence or absence of lead. Consequently, the OSHA regulations governing worker protection for lead-based paint may apply to work practices including the disturbance of paint systems with detectable levels of lead. Destructive actions (sanding, burning, demolition, component removal, paint preparation) to the lead-containing paint surfaces will require the contractor comply with the standards of OSHA, including but not limited to initial exposure monitoring, the use of personal protective equipment, and medical surveillance.

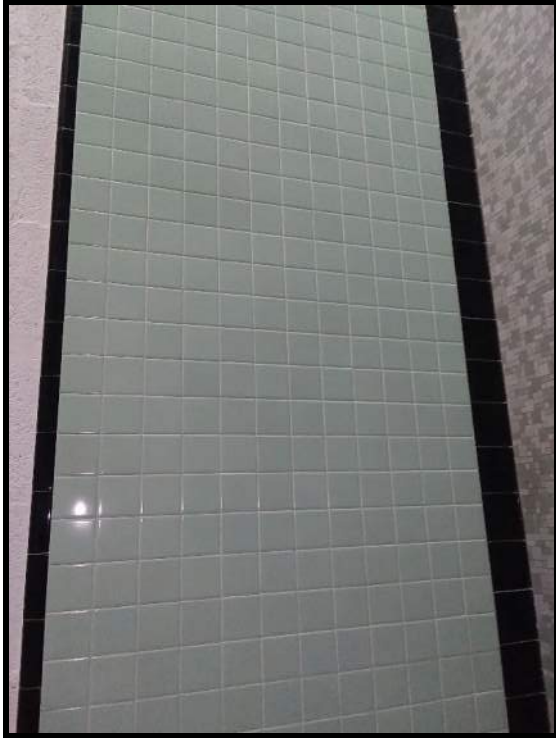
10 Green and black ceramic tile in men's restroom tested positive for lead based paint (5.40-19.90 mg/cm²).

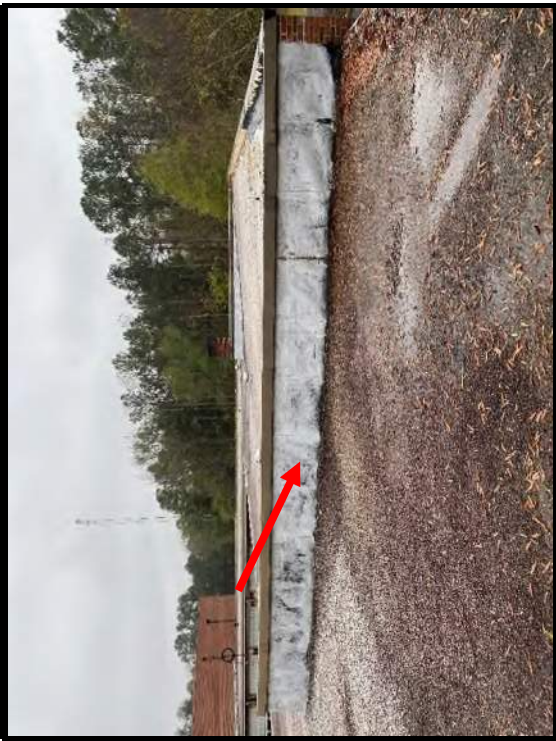
11 Silver sealant on parapet walls tested (<1% chrysotile) PLM analysis and no asbestos detected by TEM.

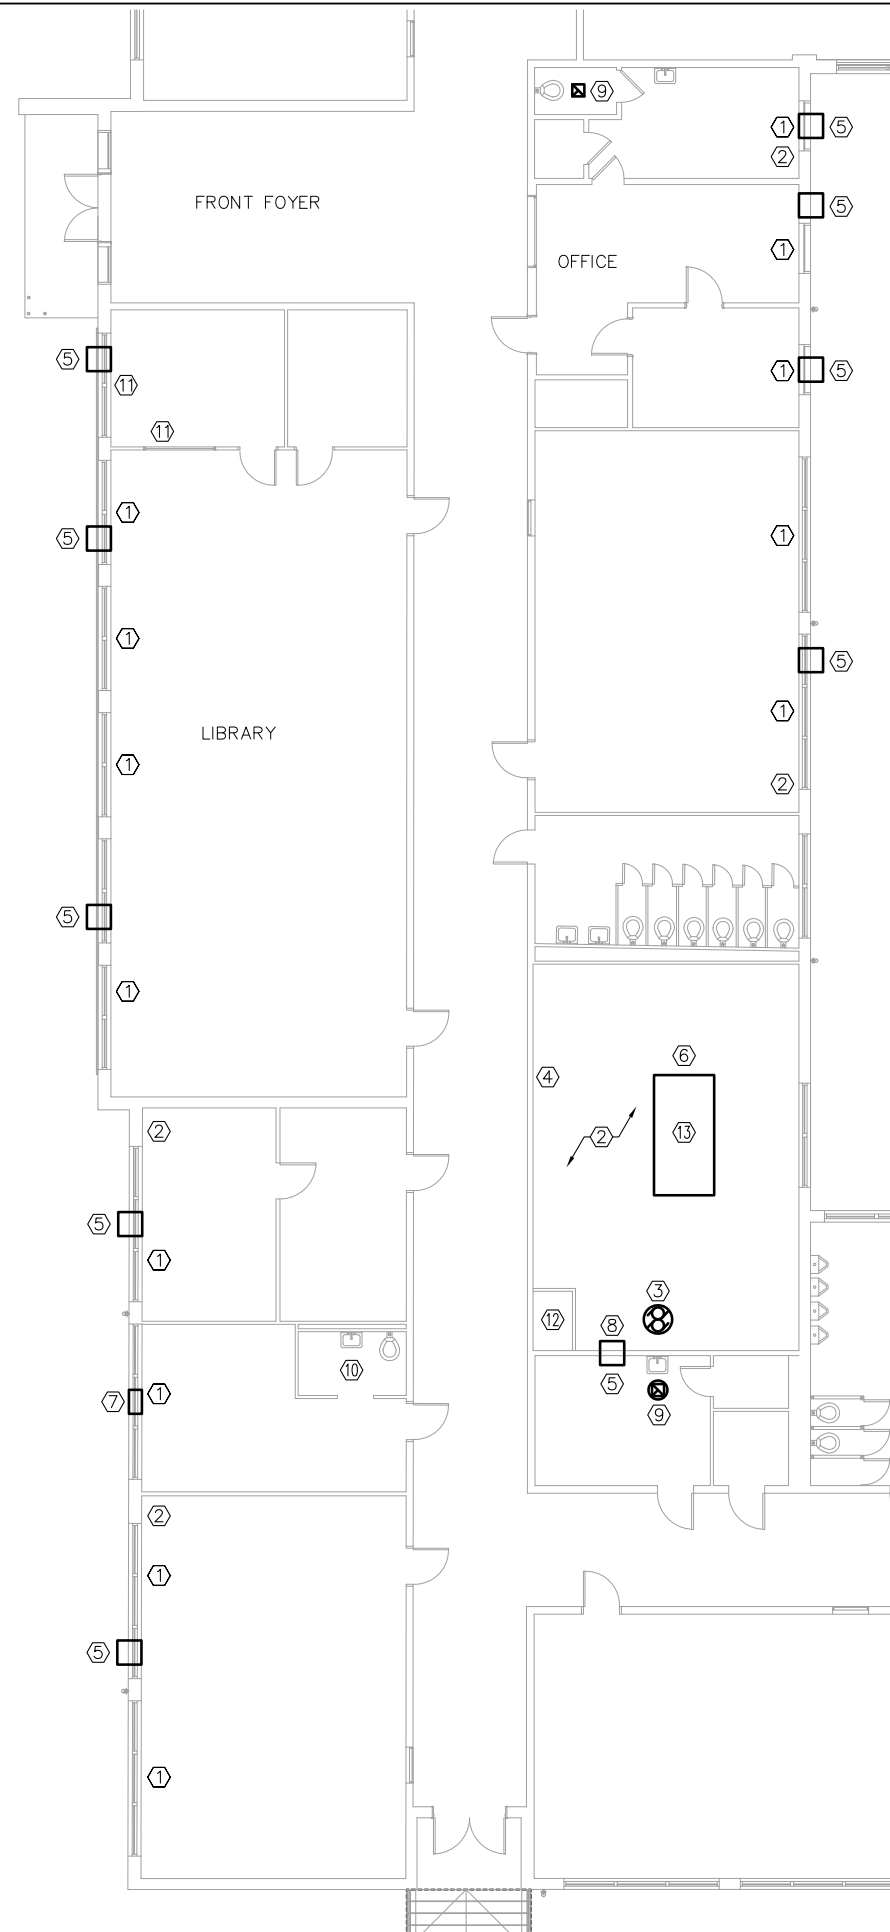
FOYER AND SCHOOL OFFICES
SCALE: NTS

- KEYED NOTES (THIS SHEET ONLY)**
- ① STEAM RADIATOR.
 - ② EXPOSED PIPE INSULATION DAMAGED MISSING OR WRONG TYPE. INSULATION SHOULD BE TESTED FOR ASBESTOS.
 - ③ EXISTING STEAM CONDENSATE RETURN PUMPS.
 - ④ EXISTING BOILER CONTROLS.
 - ⑤ WINDOW AC UNIT INSTALLED.
 - ⑥ ROOF LEAKS DAMAGING PIPE INSULATION.
 - ⑦ WINDOW AC UNIT HAS BEEN REMOVED.
 - ⑧ THRU WALL AC UNIT DISCHARGES INTO ADJACENT BOILER ROOM.
 - ⑨ ROOF MOUNTED EXHAUST FAN.
 - ⑩ NO EXHAUST IN TOILET.
 - ⑪ OVERHEAD STEAM RADIATORS.
 - ⑫ RECOMMEND HAVING BRICK CHIMNEY INSPECTED IF BEING REUSED IN THE FUTURE.
 - ⑬ EXISTING HEATING STEAM BOILER, PEERLESS MODEL LCE-19-W/S, MFG: 2001, LAST INSPECTION 9/25/2015. NATURAL GAS.
 - ⑭ EXISTING STEAM CONDENSATE RETURN PUMPS.
 - ⑮ EXISTING BOILER CONTROLS.

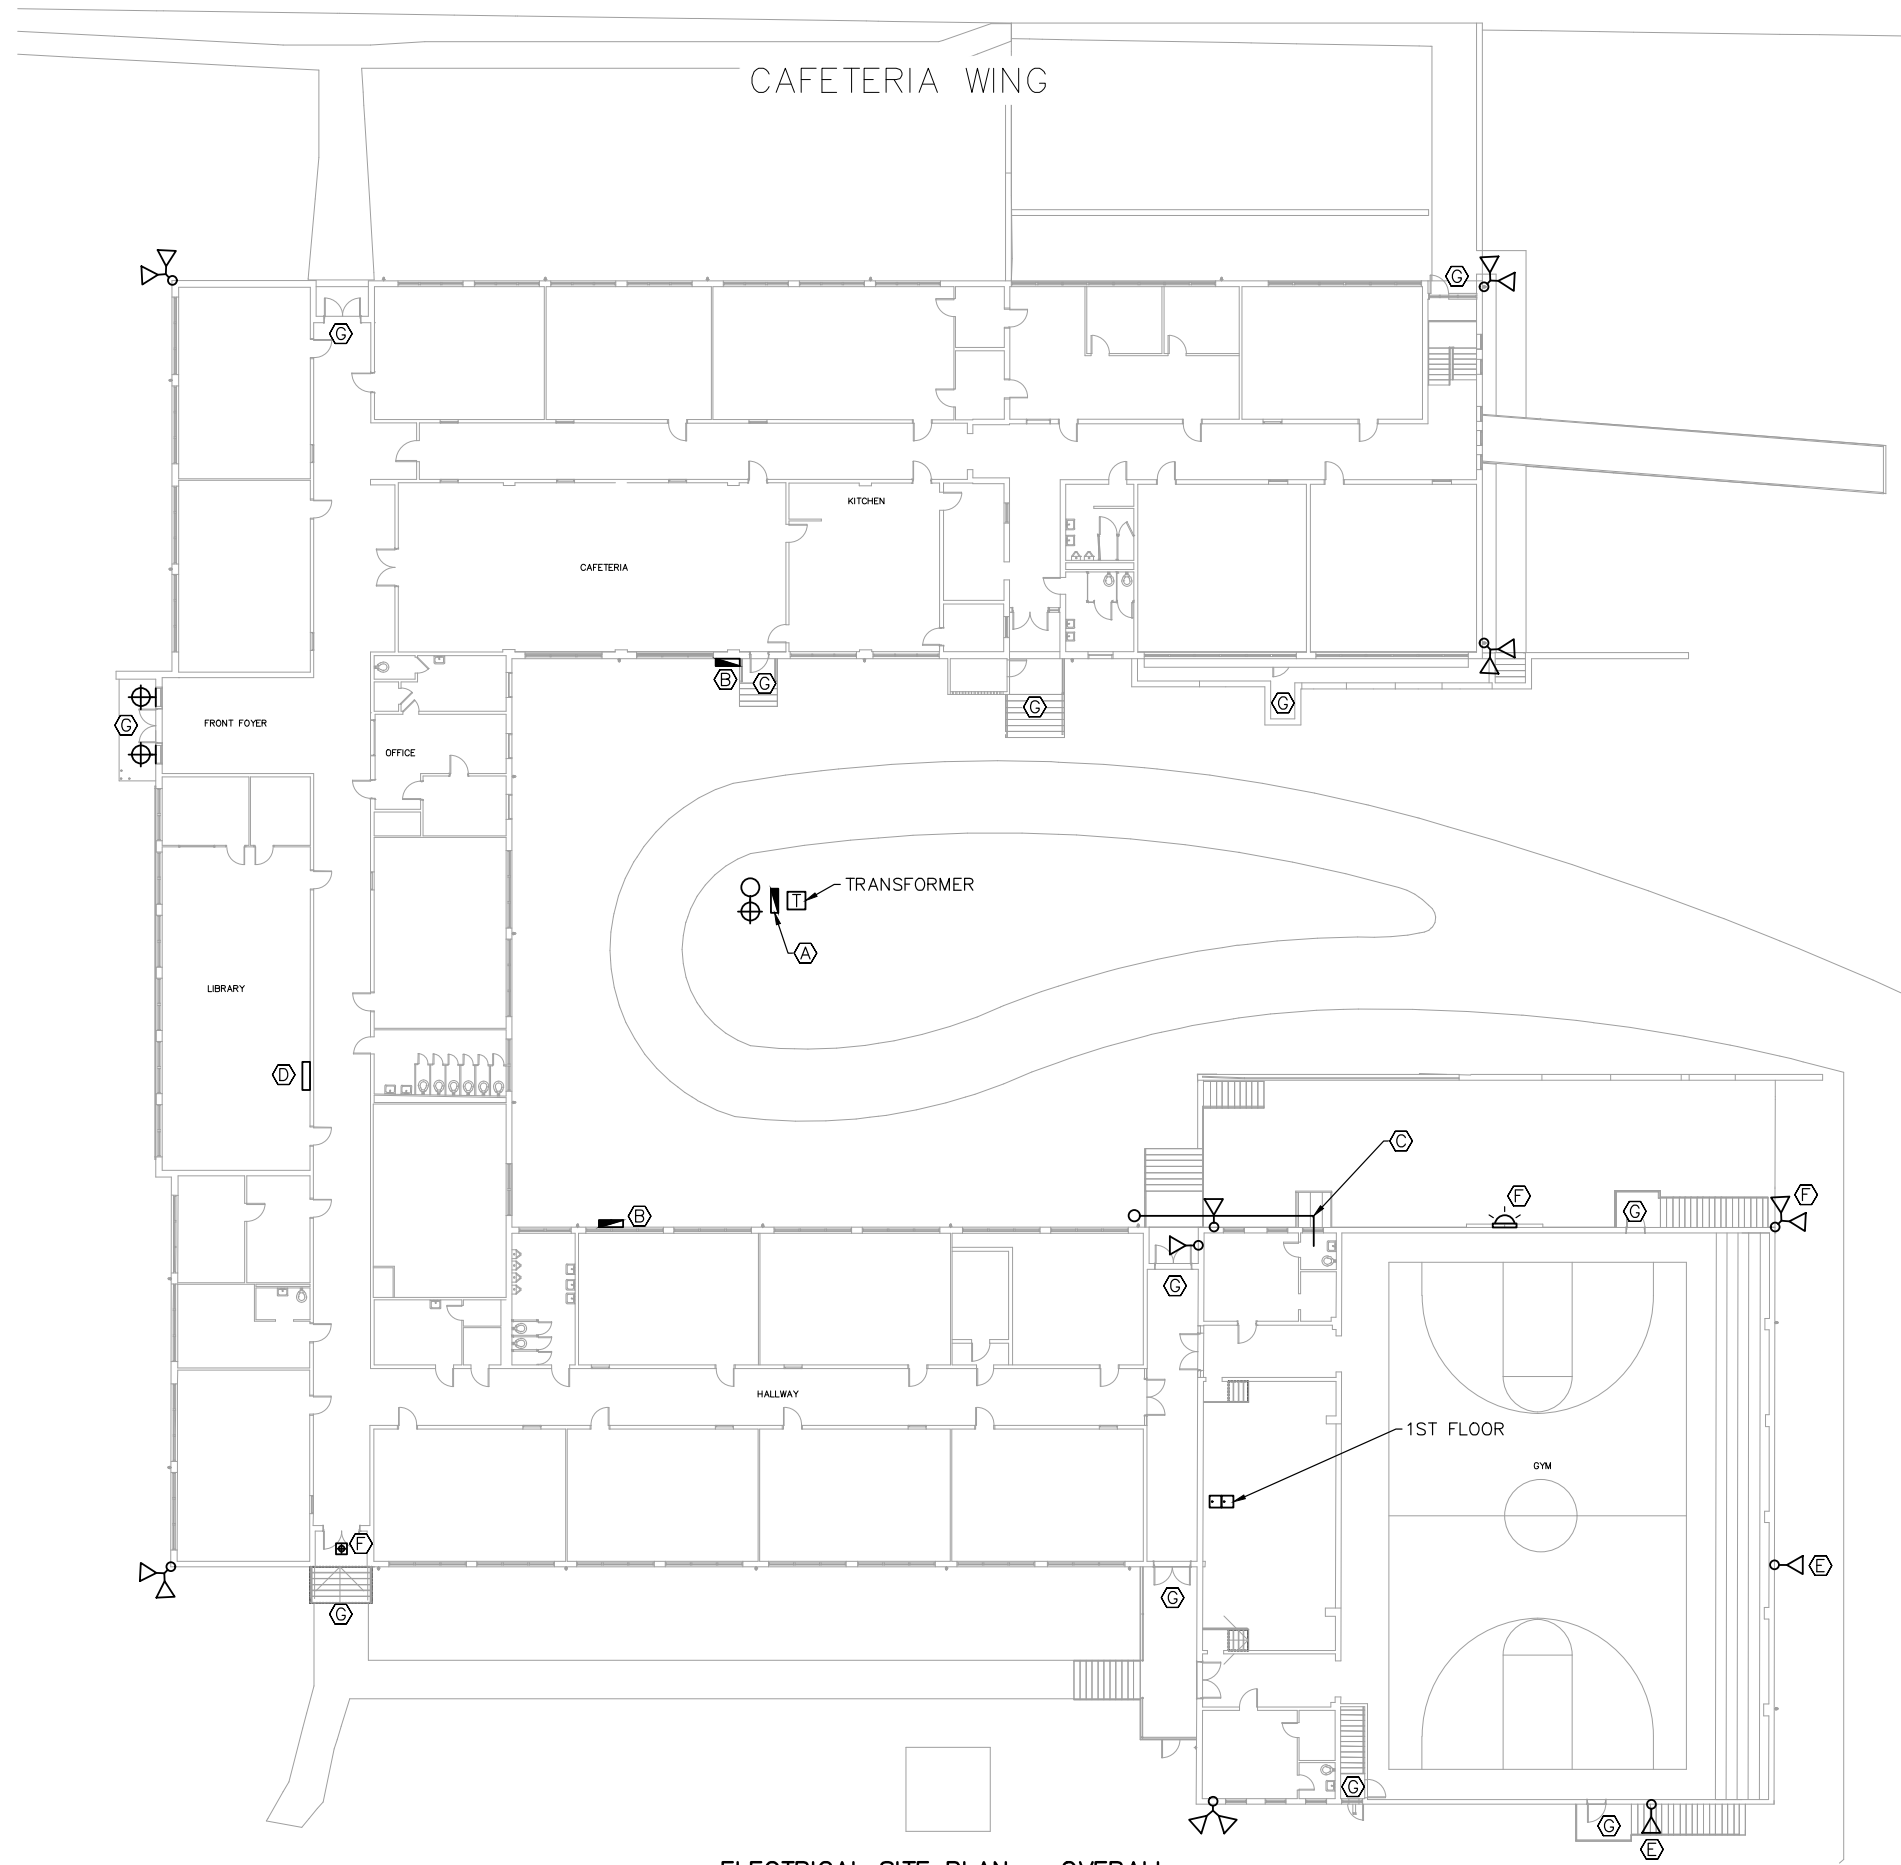
ELECTRICAL SITE PLAN - OVERALL
SCALE: NTS

- KEYED NOTES (THIS SHEET ONLY)**
- (A) EXTERIOR DISTRIBUTION PANEL.
 - (B) 225AMP HVAC PANEL.
 - (C) CIRCUIT INSTALLED IN AN UNCONVENTIONAL MANNER.
 - (D) BOILER CONTROLS LOCATED IN BASEMENT.
 - (E) LIGHT FIXTURE HAS BEEN REMOVED AND THE JUNCTION BOX HAS BEEN FILLED WITH CONCRETE.
 - (F) DAMAGED LIGHT FIXTURE.
 - (G) NO EMERGENCY EGRESS LIGHTING.

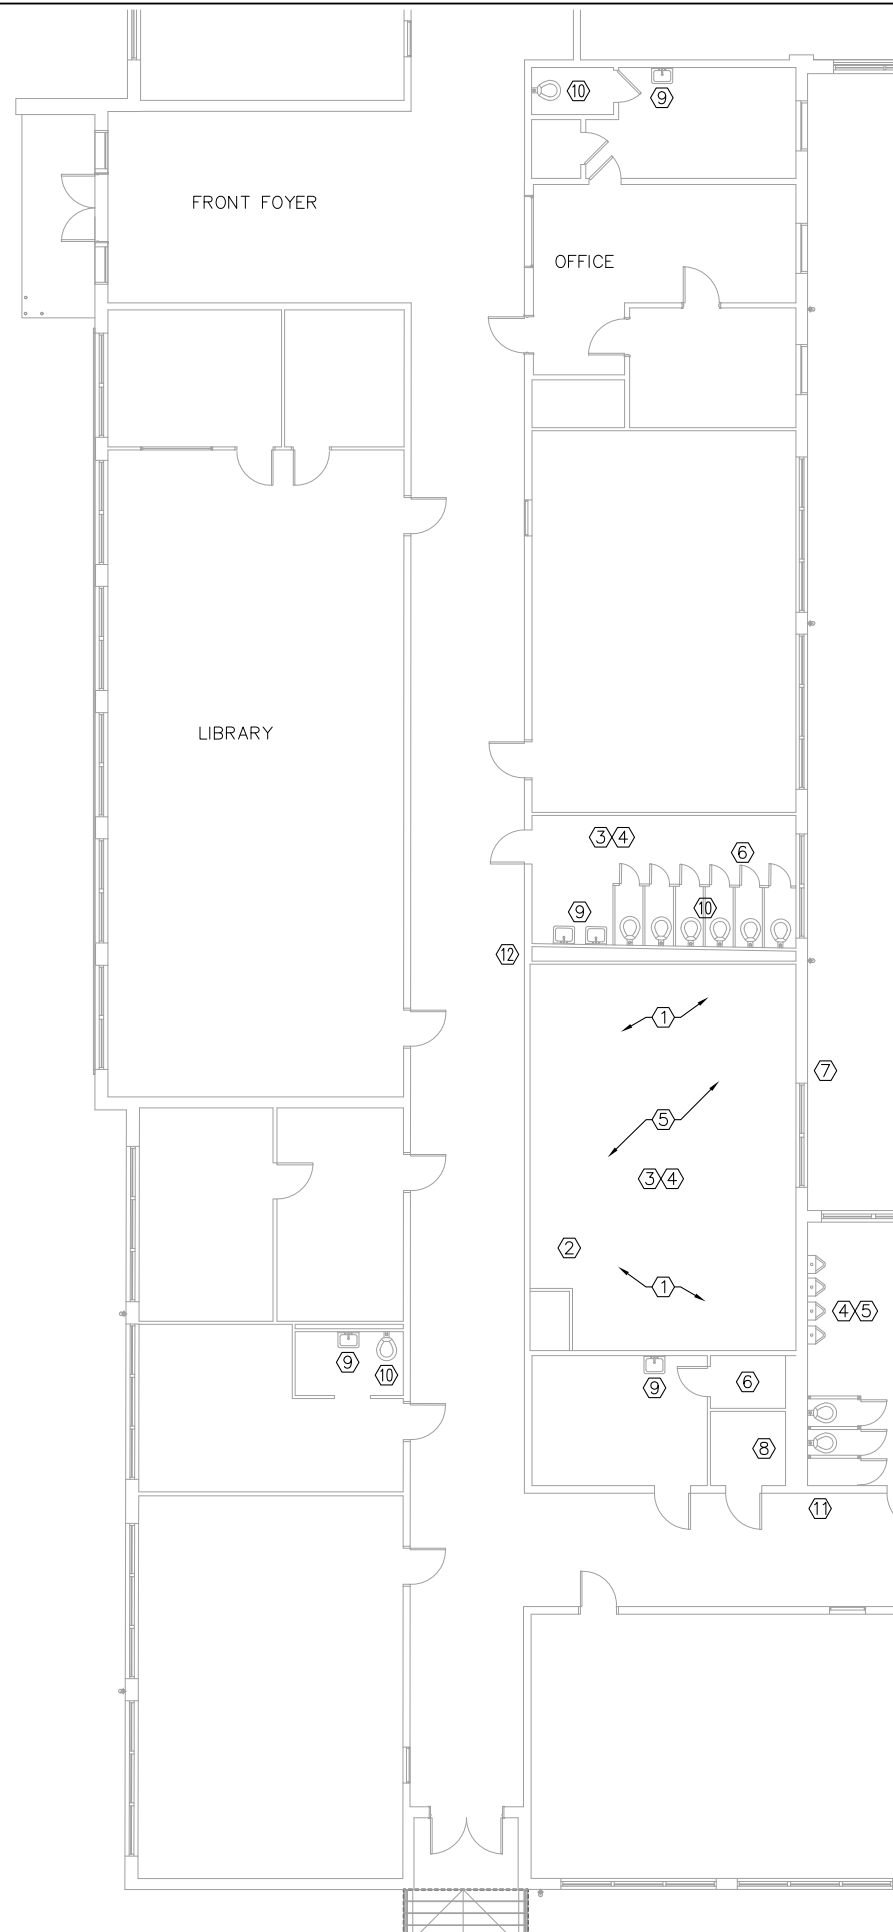
FOYER AND SCHOOL OFFICES
SCALE: NTS

- KEYED NOTES (THIS SHEET ONLY)**
- ① FLOOR DRAINS ARE CLOGGED AND NEED TO BE CLEANED.
 - ② 40 GALLON NATURAL GAS WATER HEATER, BY CRAFTMASTER, MFG DATE: 2007. NO DRAIN PAN, EXPANSION TANK, VACUUM BREAKER.
 - ③ MOST OF THE WASTE PIPING FOR THIS AREA IS CAST IRON THOUGH SOME PVC HAS BEEN USED.
 - ④ MOST OF THE DOMESTIC WATER PIPING IN THIS AREA IS COPPER. HOT WATER SYSTEM DOES NOT APPEAR TO BE RECIRCULATED.
 - ⑤ PIPE INSULATION INSTALLED IS IN NEED OF REPLACEMENT OR REPAIR.
 - ⑥ STANDING WATER IN CRAWL SPACE.
 - ⑦ GAS METER FOR BOILER ROOM.
 - ⑧ MOP SINK/FAUCET.
 - ⑨ WALL MOUNTED LAVATORY.
 - ⑩ FLOOR MOUNTED FLUSH VALVE TOILET.
 - ⑪ WALL MOUNTED DRINKING FOUNTAIN. (NON ADA)
 - ⑫ WALL MOUNTED DRINKING FOUNTAIN.

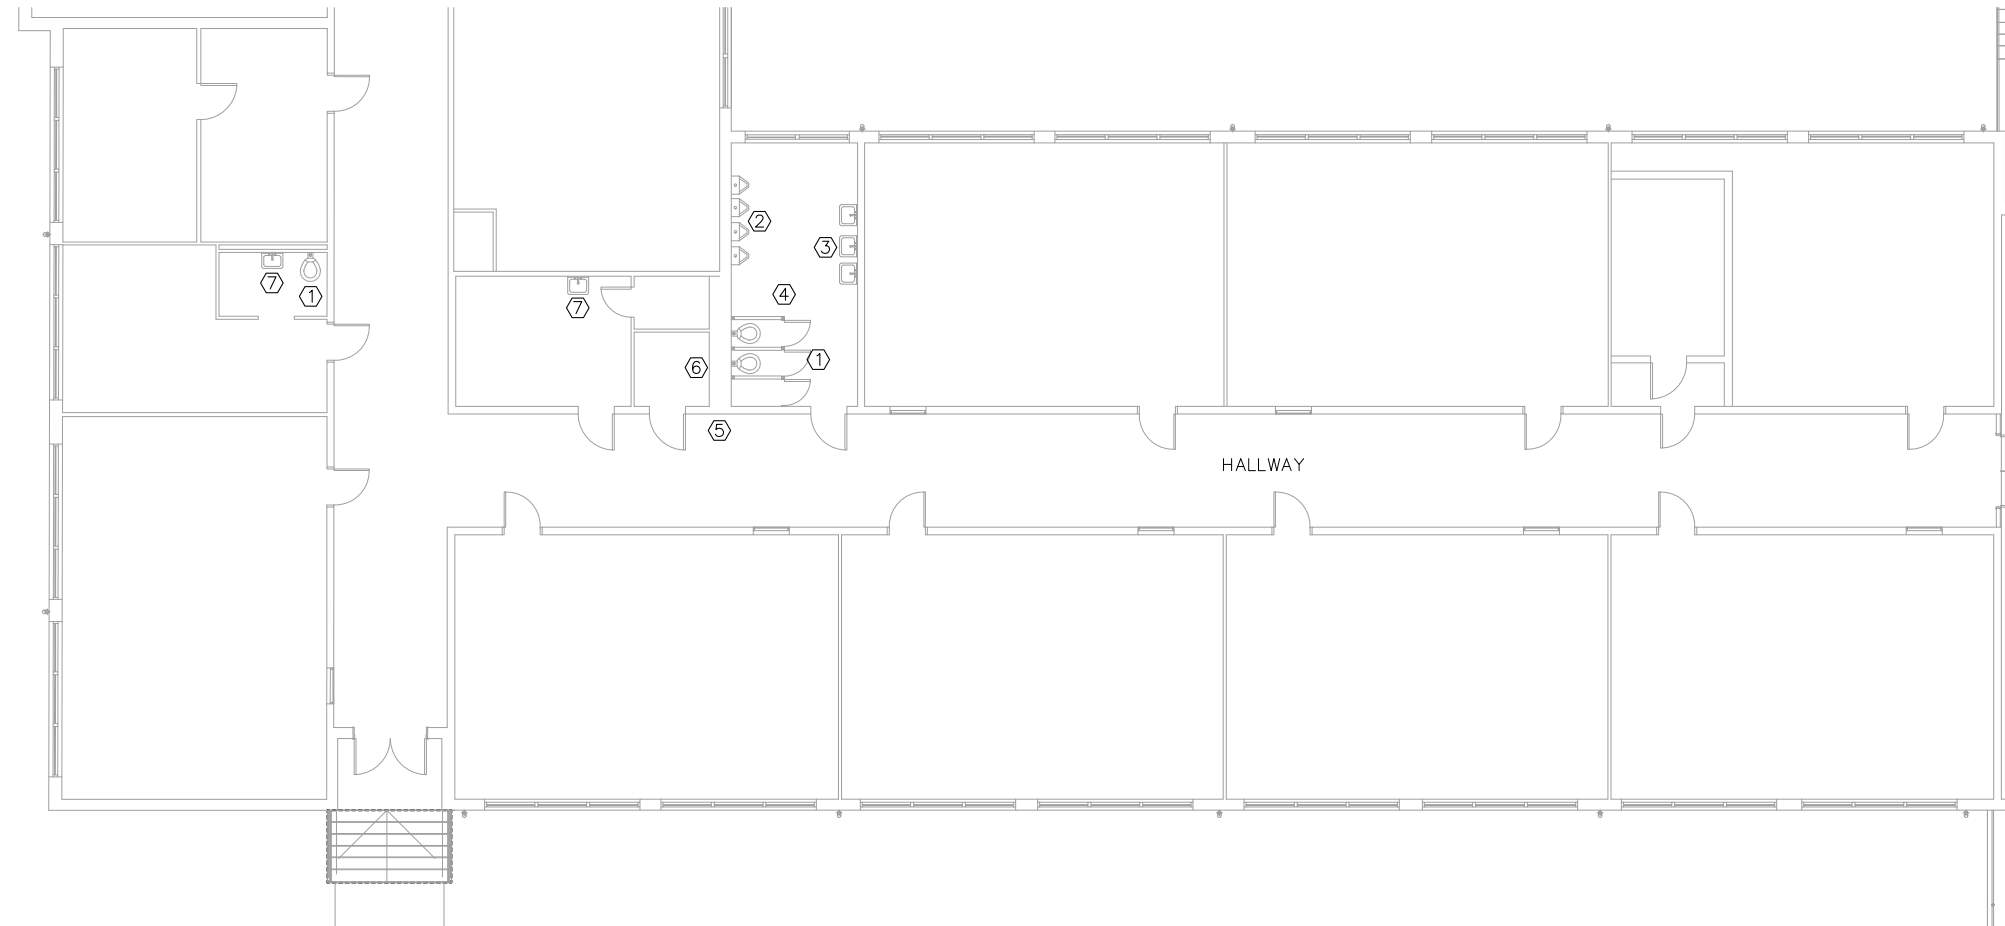
CLASSROOM WING
SCALE: NTS

- ① FLOOR MOUNTED FLUSH VALVE TOILETS.
- ② WALL MOUNTED URINALS. THREE ARE MISSING.
- ③ WALL MOUNTED LAVATORIES TWO ARE MISSING.
- ④ BATHROOM FLOOR DRAIN RISES ABOVE EXISTING TILE FLOOR – TRIP HAZARD.
- ⑤ WALL MOUNTED DRINKING FOUNTAIN. (NON-ADA)
- ⑥ MOP SINK.
- ⑦ WALL MOUNTED LAVATORY.

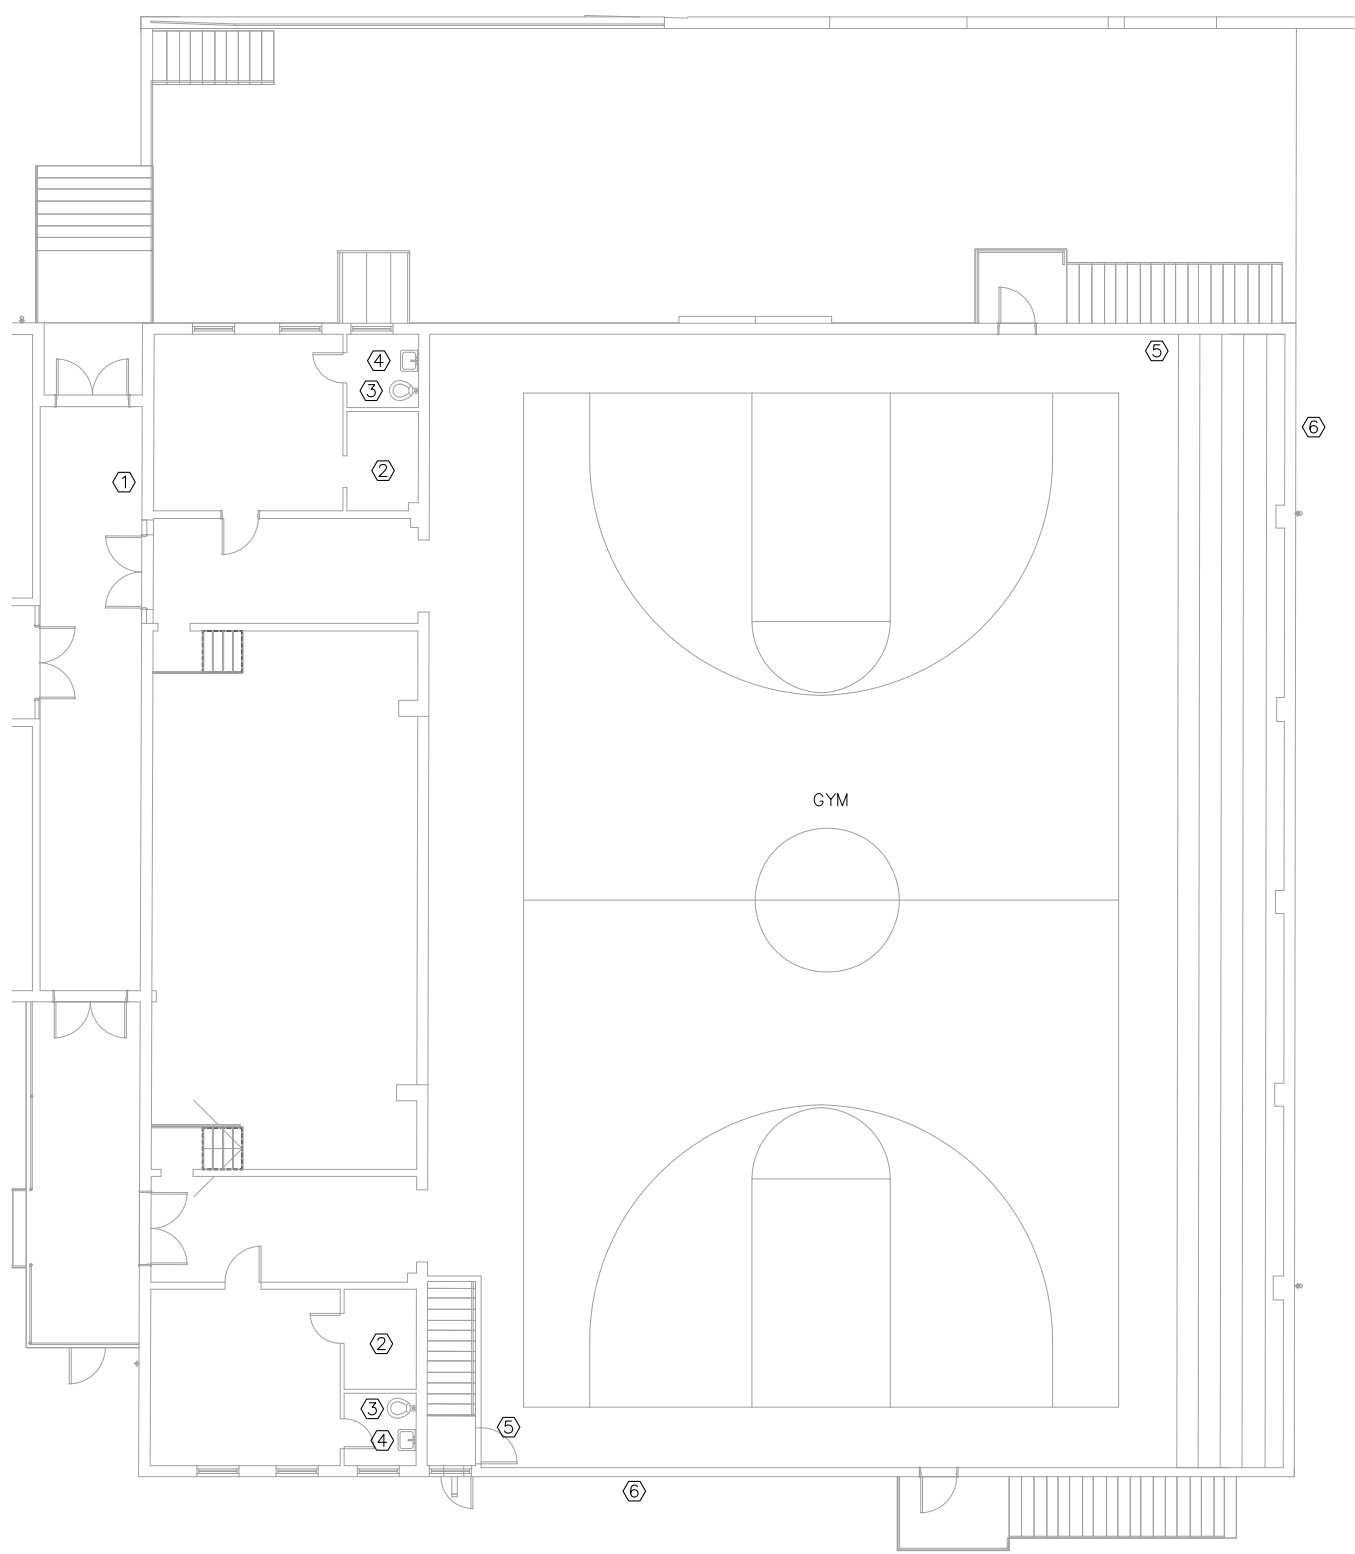
GYM - UPPER LEVEL
SCALE: NTS

- KEYED NOTES (THIS SHEET ONLY)**
- ① FLOOR MOUNTED WATER COOLER. (NON-ADA).
 - ② SHOWERS.
 - ③ FLOOR MOUNTED FLUSH VALVE TOILET.
 - ④ WALL MOUNTED LAVATORY.
 - ⑤ GAS PIPING TO SUSPEND FAN FORCED HEATER.
 - ⑥ GAS METER. (AT GRADE, LEVEL).

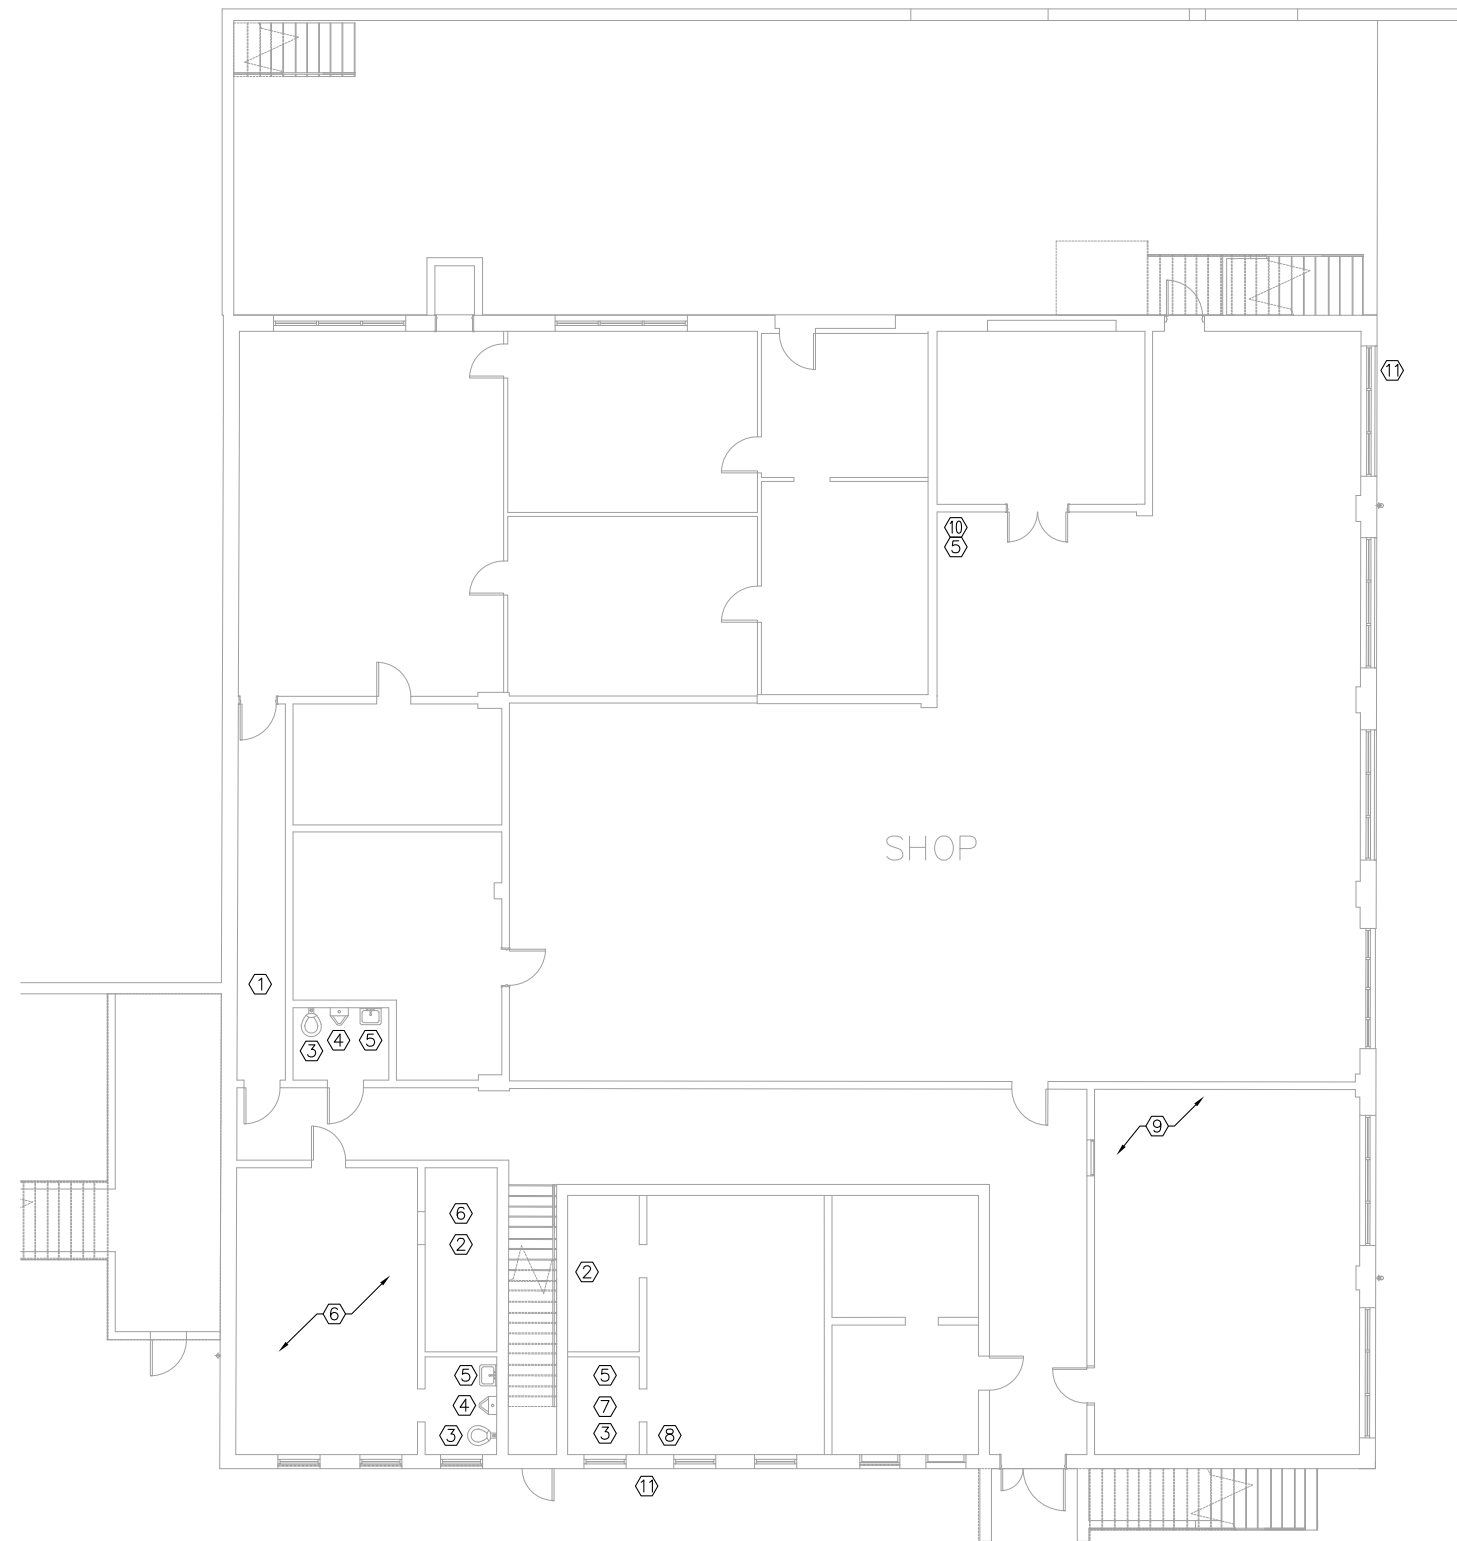
GYM - LOWER LEVEL
SCALE: NTS

- KEYED NOTES (THIS SHEET ONLY)**
- ① WASTE CLEAN OUT, CAP ABOVE FINISHED CONCRETE FLOOR ELEVATION - TRIP HAZARD.
 - ② SHOWERS.
 - ③ FLOOR MOUNTED FLUSH VALVE TOILET.
 - ④ WALL MOUNTED FLUSH VALVE URINAL.
 - ⑤ WALL MOUNTED LAVATORY.
 - ⑥ CLOGGED FLOOR DRAINS - NEED TO BE CLEANED OUT.
 - ⑦ URINAL REMOVED.
 - ⑧ PAST WATER HEATER LOCATION - NOT INSTALLED.
 - ⑨ COMPRESSED AIR REGULATOR/QUICK CONNECTS.
 - ⑩ WALL MOUNTED WATER COOLER.
 - ⑪ GAS REGULATOR/METER.
