**Asbestos & Lead-Based Paint
Assessment Report
Whitmire Town Hall
Whitmire, South Carolina
S&ME Project No. 4261-18-009**

Reference: **Asbestos & Lead-Based Paint Assessment**
Whitmire Town Hall
210 Main Street
Whitmire, South Carolina
S&ME Project No. 4261-18-009

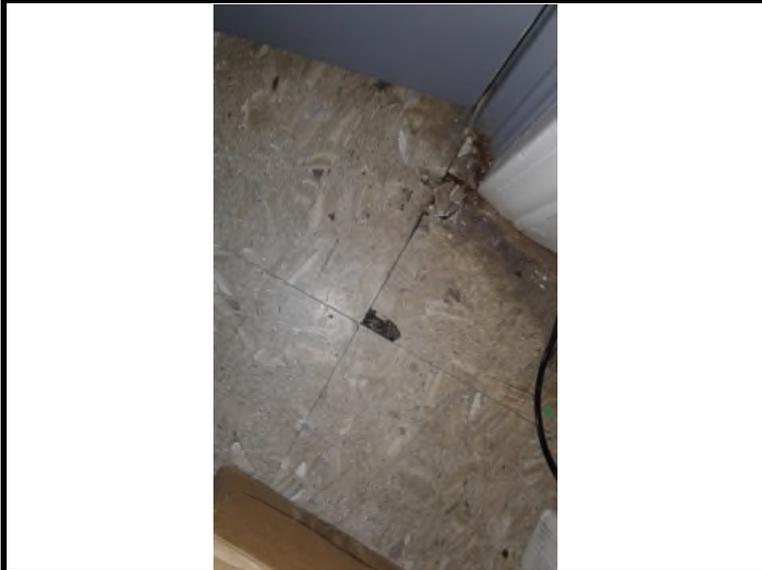
- *12-inch Gray vinyl floor tiles and associated black mastic* (3% chrysotile) located in the Police Department and north corridor – Refer to Photograph 3. The asbestos-containing vinyl floor tiles and associated black mastic are Category I non-friable materials in good condition. Approximately 280 square feet of the floor tiles and black mastic is estimated to be present.

3 View of the 12" gray vinyl floor tile and associated black mastic located in the police department and north corridor (3% chrysotile).

S&ME recommends proper removal and disposal of the ACMs by a licensed asbestos abatement contractor, prior to activities that may disturb an ACM. State and Federal regulations should be carefully considered in order to verify compliance before any actions are initiated that may disturb an ACM. If additional suspect ACMs not included in this report are discovered and will be disturbed by the renovation/demolition activities, bulk samples must be collected by a licensed asbestos inspector and analyzed for asbestos content, prior to disturbance of the suspect material(s).

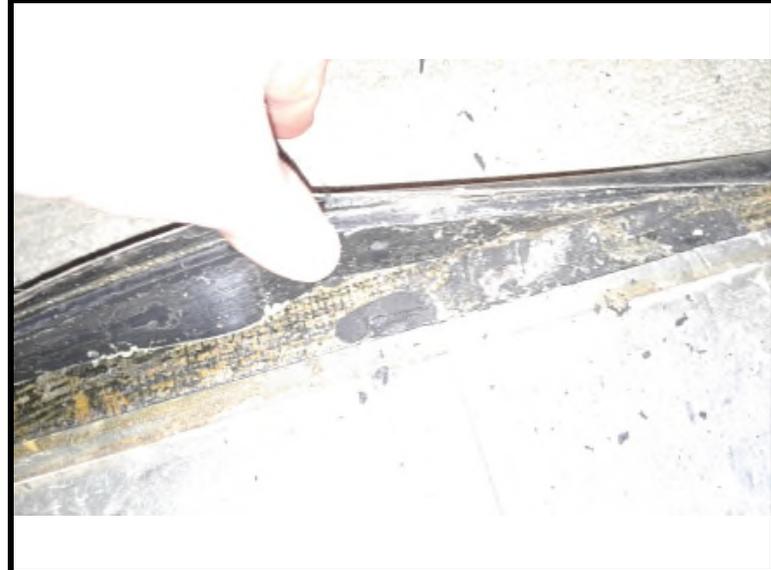
- *Black vinyl floor tiles* (10% chrysotile) located beneath the 12-inch dark gray vinyl floor tile in the lobby and beneath the carpeting in the clerks office – Refer to Photograph 4. The asbestos-containing vinyl floor tiles are Category I non-friable materials in good condition. Approximately 250 square feet of the floor tiles are estimated to be present.

4 View of the black vinyl floor tile located beneath the 12" dark gray vinyl floor tile in the lobby and beneath carpeting in the clerk's office (10% chrysotile).

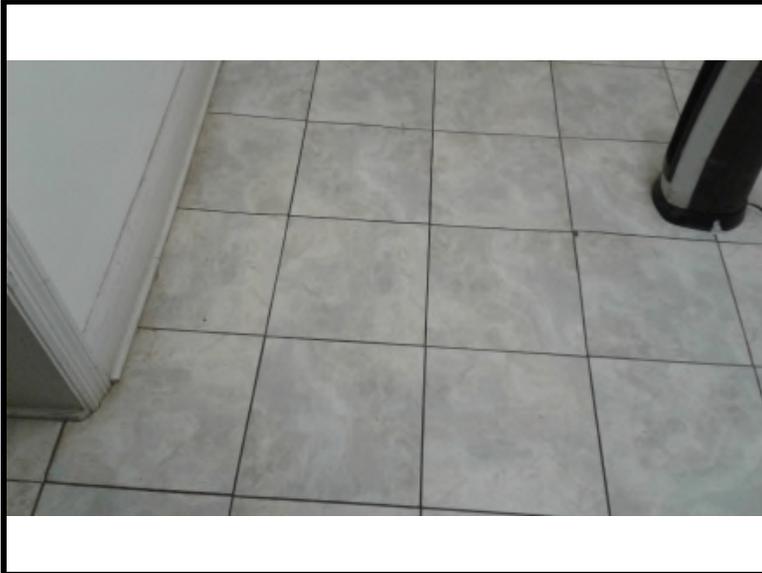
- *Tan/black mastic* (4% chrysotile) located beneath the self-adhesive floor tiles in the women's restrooms – Refer to Photograph 5. The asbestos-containing mastic is a Category I non-friable material in good condition. Approximately 15 square feet of black mastic is estimated to be present.

5 The tan/black mastic located beneath the self-adhesive vinyl floor tile in the women's restroom tested positive for asbestos (4% chrysotile).

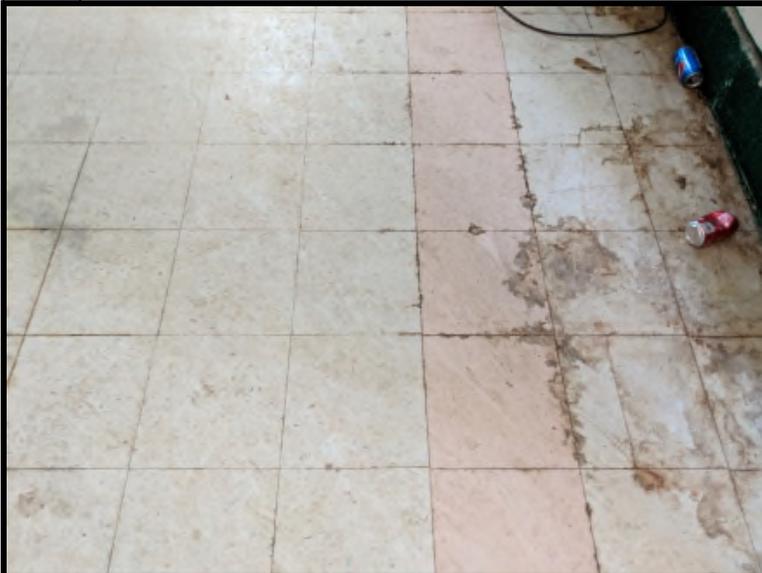
7 The 12" white and pink vinyl floor tile and associated mastic located in the garage tested negative for asbestos.

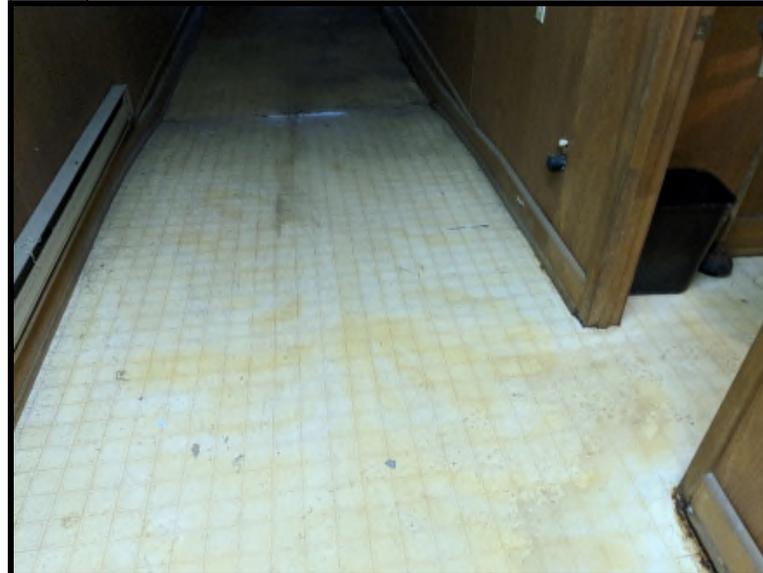
8 The tan linoleum located in the south side of the garage building tested negative for asbestos.

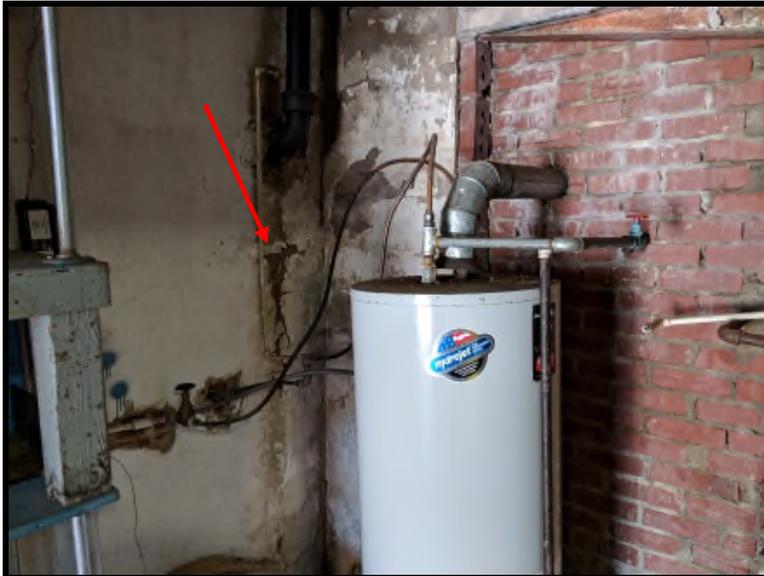
9 The plaster walls located in the garage building tested negative for asbestos.

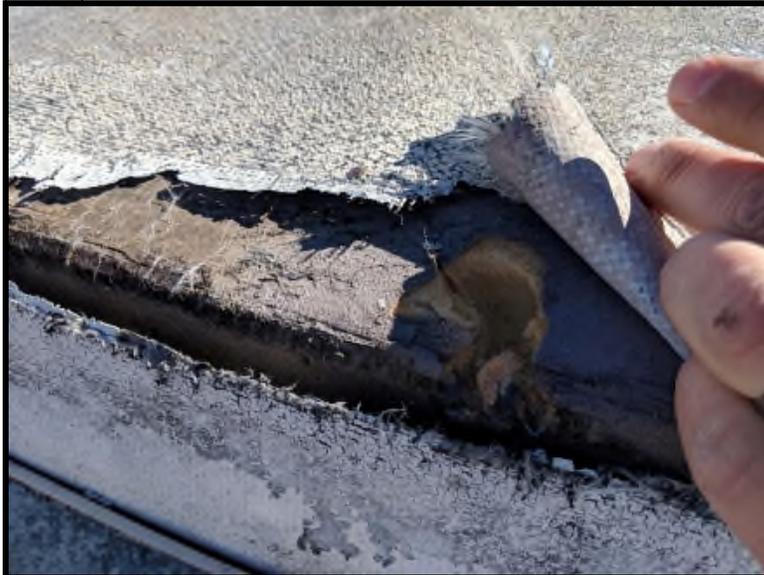
11 The cloth rolled roofing tested negative for asbestos.

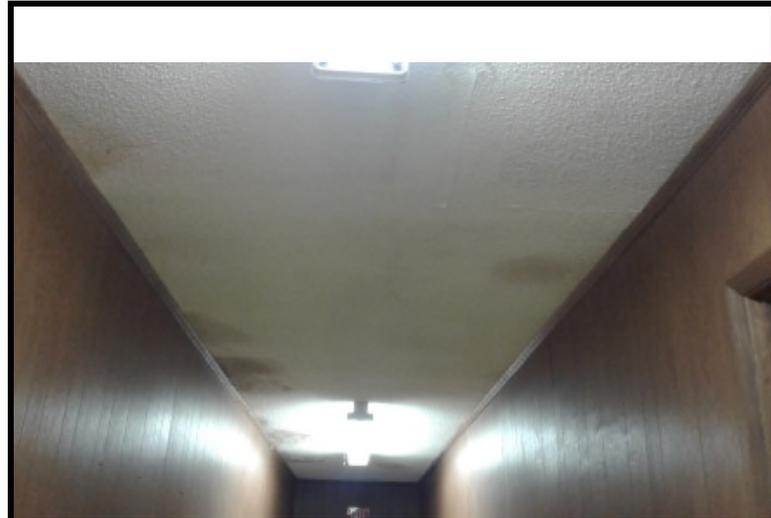
10 The spray-applied ceiling texture tested negative for asbestos.

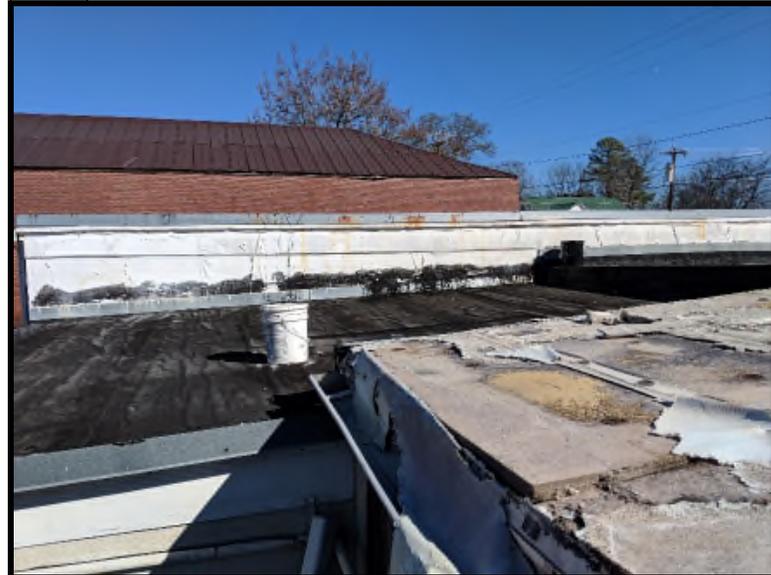
12 The asphalt rolled roofing tested negative for asbestos.
