# HAZARDOUS MATERIALS SURVEY

NEWBERRY FAIRGROUNDS

2301 ADELAIDE STREET  
NEWBERRY, SOUTH CAROLINA 29108

ECS PROJECT NO. 49:24746

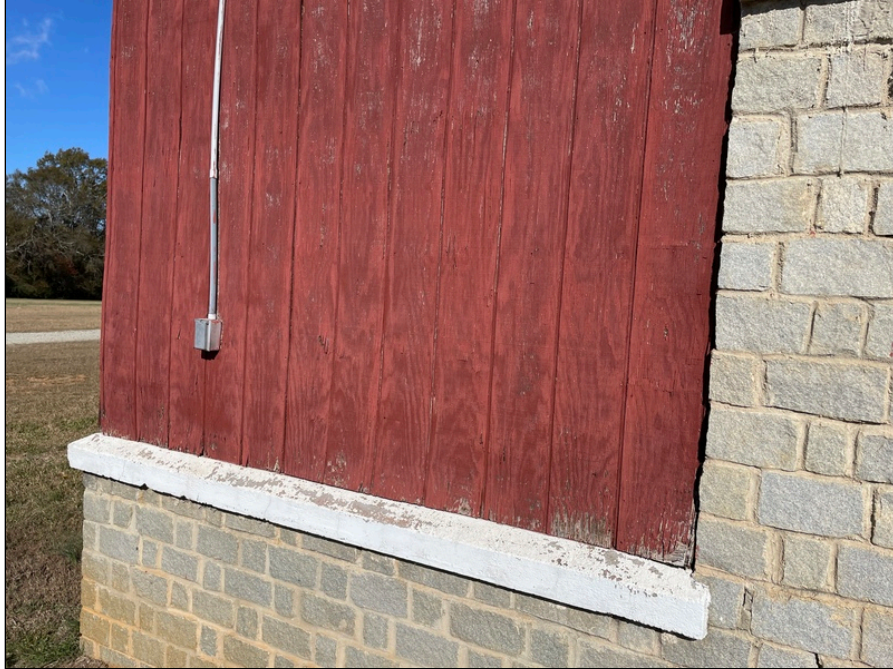
Sample ID	Color	Substrate	Component	% Lead by Weight
<b>Training Center/Carport</b>				
L1	White	Drywall	Walls	<0.00606
<b>South Barn</b>				
L2	Red	Wood	Siding	<0.00622
L3	White	Concrete	Exterior Trim	<b>0.0352</b>

5 - White LCP on Concrete Trim of South Barn

that actual personal exposures are below the Permissible Exposure Limit (PEL) of 50 micrograms per cubic meter ( $\mu\text{g}/\text{m}^3$ ) as an 8-hour Time Weighted Average (TWA). Under OSHA requirements, the contractor performing renovation work will be required to conduct this monitoring and follow applicable requirements under 29 CFR 1926.62 if disturbing lead-containing paint.

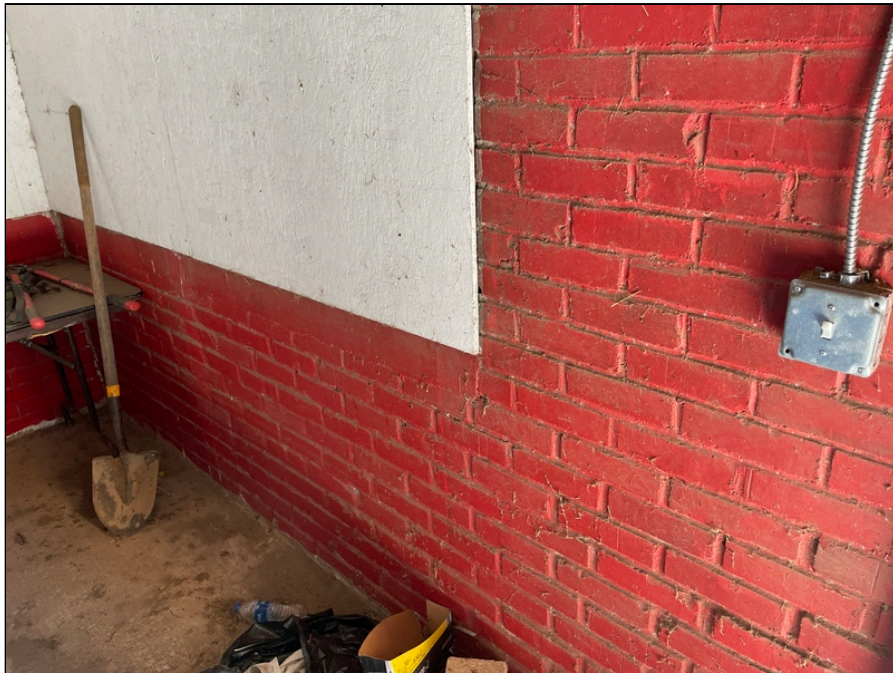
Sample ID	Color	Substrate	Component	% Lead by Weight
L4	Red	Brick	Interior Walls	<b>0.0215</b>
L5	White	Wood	Walls	<0.00595
L6	Red	Wood	Walls	<0.00612
L7	Red	Metal	Door	<0.00592
L8	White	Wood	Door/Porch	<0.00611
<b>North Barn</b>				
L9	Red	Wood	Siding	<0.00608
L10	White	Concrete	Exterior Trim	<b>0.0439</b>
<b>Bold</b> indicates LCP

6 - Red LCP on Interior Brick Walls in South Barn

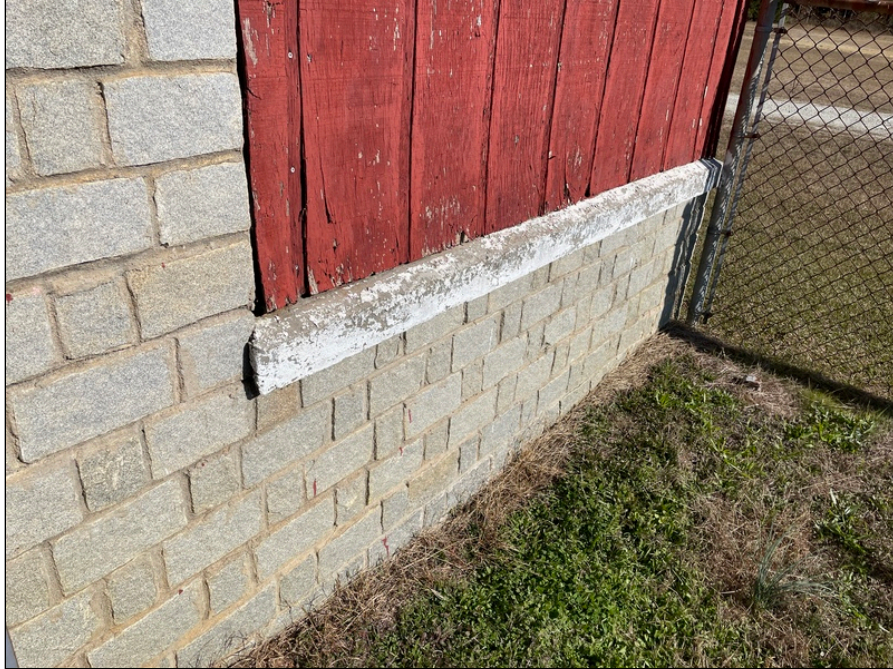
11 - White LCP on Concrete Trim of North Barn
